5 February 2019

Matthew Dodd  
Quarry Manager  
Holcim (Australia) Pty Ltd  
Mt. Shamrock Road

## **Mt. Shamrock Quarry - Toomuc Valley Slope Inspection, January 2019**

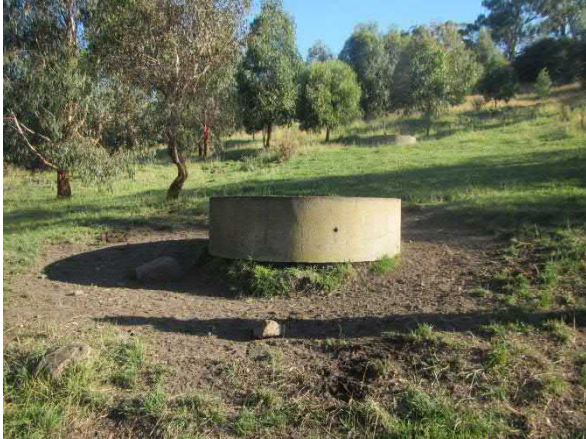
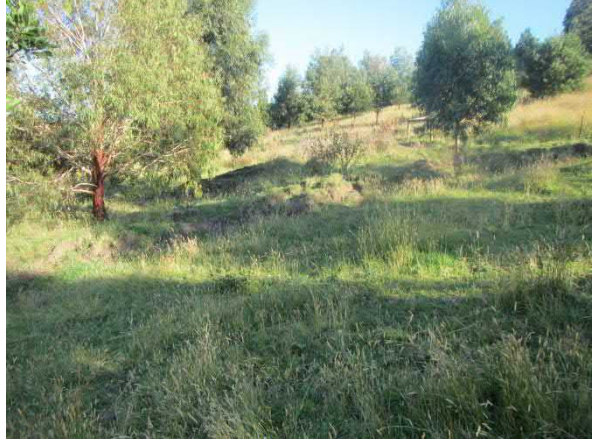
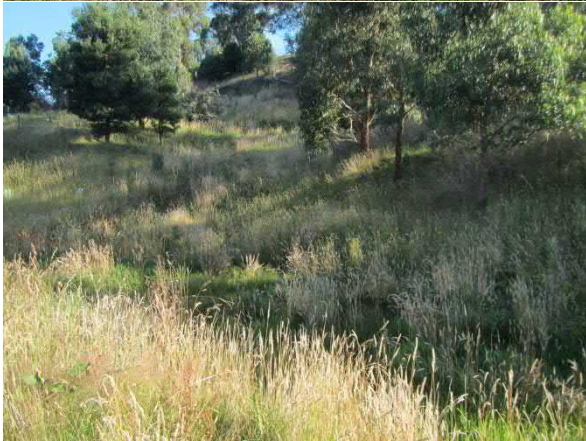
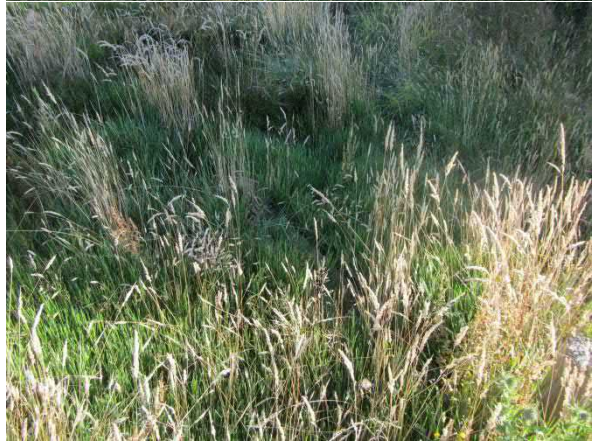
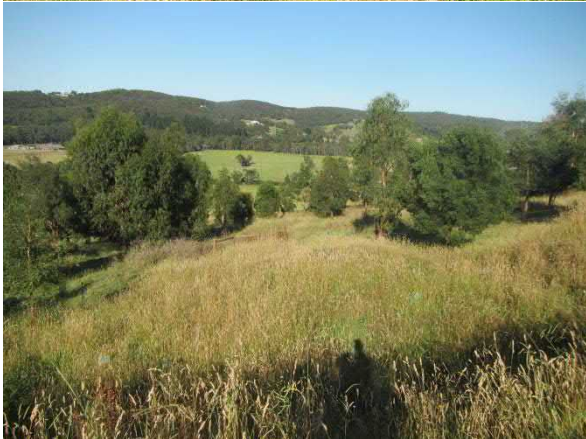
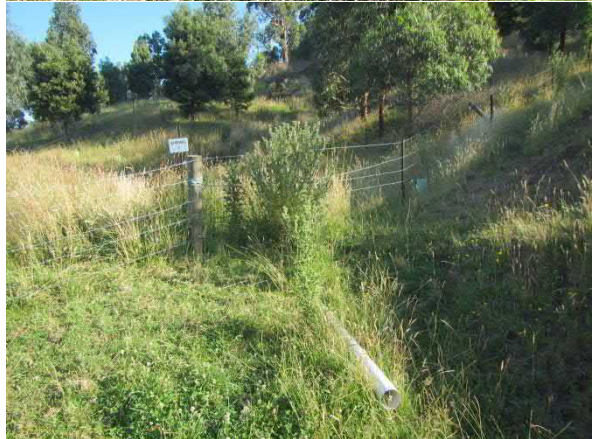
**Mass02**

- Changes have been observed at
  - Mass02: Within this mass there is an existing small dam. In the 2017 inspection, it was reported that part of the dam wall has washed out as a result of a recent over topping event. The previous landowner had installed a small agricultural glory hole arrangement to maintain a maximum water level. This system consists of a small tank inserted in the dam with two small diameter flexible poly pipes (<50mm) to transfer water down slope to stock tanks and an open drain located at the lower third of the slope. During the review period, it is understood that Holcim have lowered the gloryhole spillway, and added contingency in the form of an overflow pipe which outlets water to the west in order to prevent embankment overtopping (Attachment 2). A fence is also present to prevent animal access.

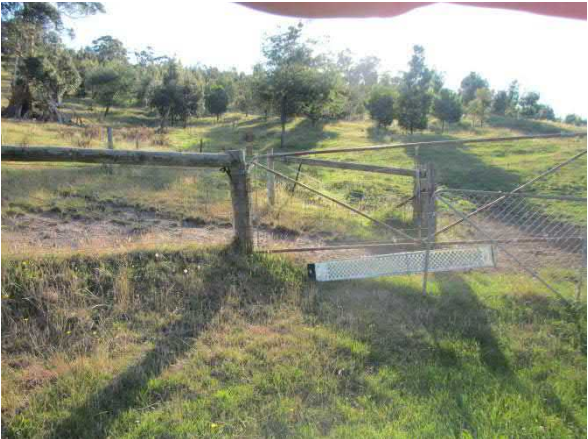
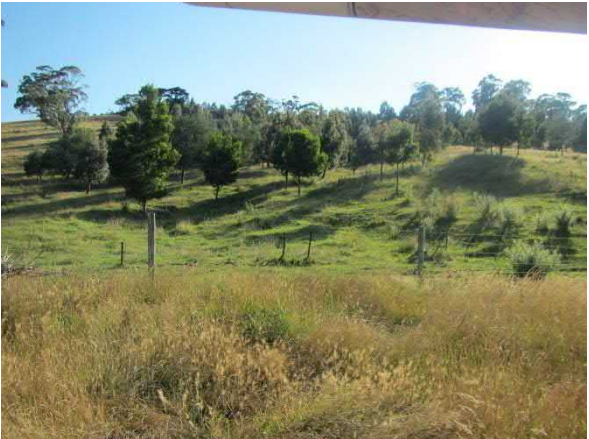
**Mass03**

Mass03	<ul style="list-style-type: none"> <li>Overall the area is well vegetated with dense grass cover and small to medium shrubs and trees throughout.</li> <li>Whilst the slope surface is hummocky, this appears to be associated with historical major landslips and no evidence of recent or ongoing instability was observed.</li> <li>Holcim representative indicated that there is no known slope movement in this area over the review period and in general the area is considered to have remained stable over the last 7 years.</li> </ul>
Mass04	<p>General Slope Stability of Mass04 Area</p> <ul style="list-style-type: none"> <li>Overall the area is well vegetated with dense grass cover and small to medium shrubs and trees throughout.</li> <li>Whilst the slope surface is hummocky, this appears to be associated with historical major landslips and no evidence of recent or ongoing instability was observed (exception being small circular failure of old back scarp, as discussed below).</li> <li>Holcim representative indicated that there is no known slope movement in this area over the review period and in general the area is considered to have remained stable over the last 5 years.</li> </ul> <p>Localised Small Circular Failure of Old Backscarp (refer Attachment 2)</p> <ul style="list-style-type: none"> <li>During review period a small, shallow circular failure of an old backscarp from the larger historical landslide has occurred. The slope behind the failure is relatively flat, appeared dry and is vegetated with grass and bushes. There is no evidence of tension cracks behind the failure.</li> <li>The failure measures about 5 m in width and ~1.5 m in height. The slope below slump is damp, likely associated with a spring, with appreciable surface water present.</li> <li>The circular failure is small in volume and, given that the location is isolated from any downhill infrastructure, is not considered to be a significant geological risk.</li> </ul> <p><b>Remedial Solution Treatments</b></p> <p>The following remedial options have been implemented during the review period:</p> <ol style="list-style-type: none"> <li>Construct a barricade to prevent animal access to the area to allow vegetation to establish, it is currently fenced on all sides at approximately a 50m radius.</li> <li>Revegetate behind the failure / old backscarp with deep root (but small canopy) shrubs / bushes and grasses</li> <li>Revegetate in the saturated area below the failure with wet tolerant species, ie swampy gums, river gum, boobiellas</li> <li>Revegetate the slump surface with grasses.</li> <li>Maintain regular documented inspections and if conditions deteriorate notify suitably qualified geotechnical engineer for further direction.</li> </ol> <p>It is deemed important to continue to monitor the vegetation of this scarp to ensure that washouts do not inhibit the progress.</p>

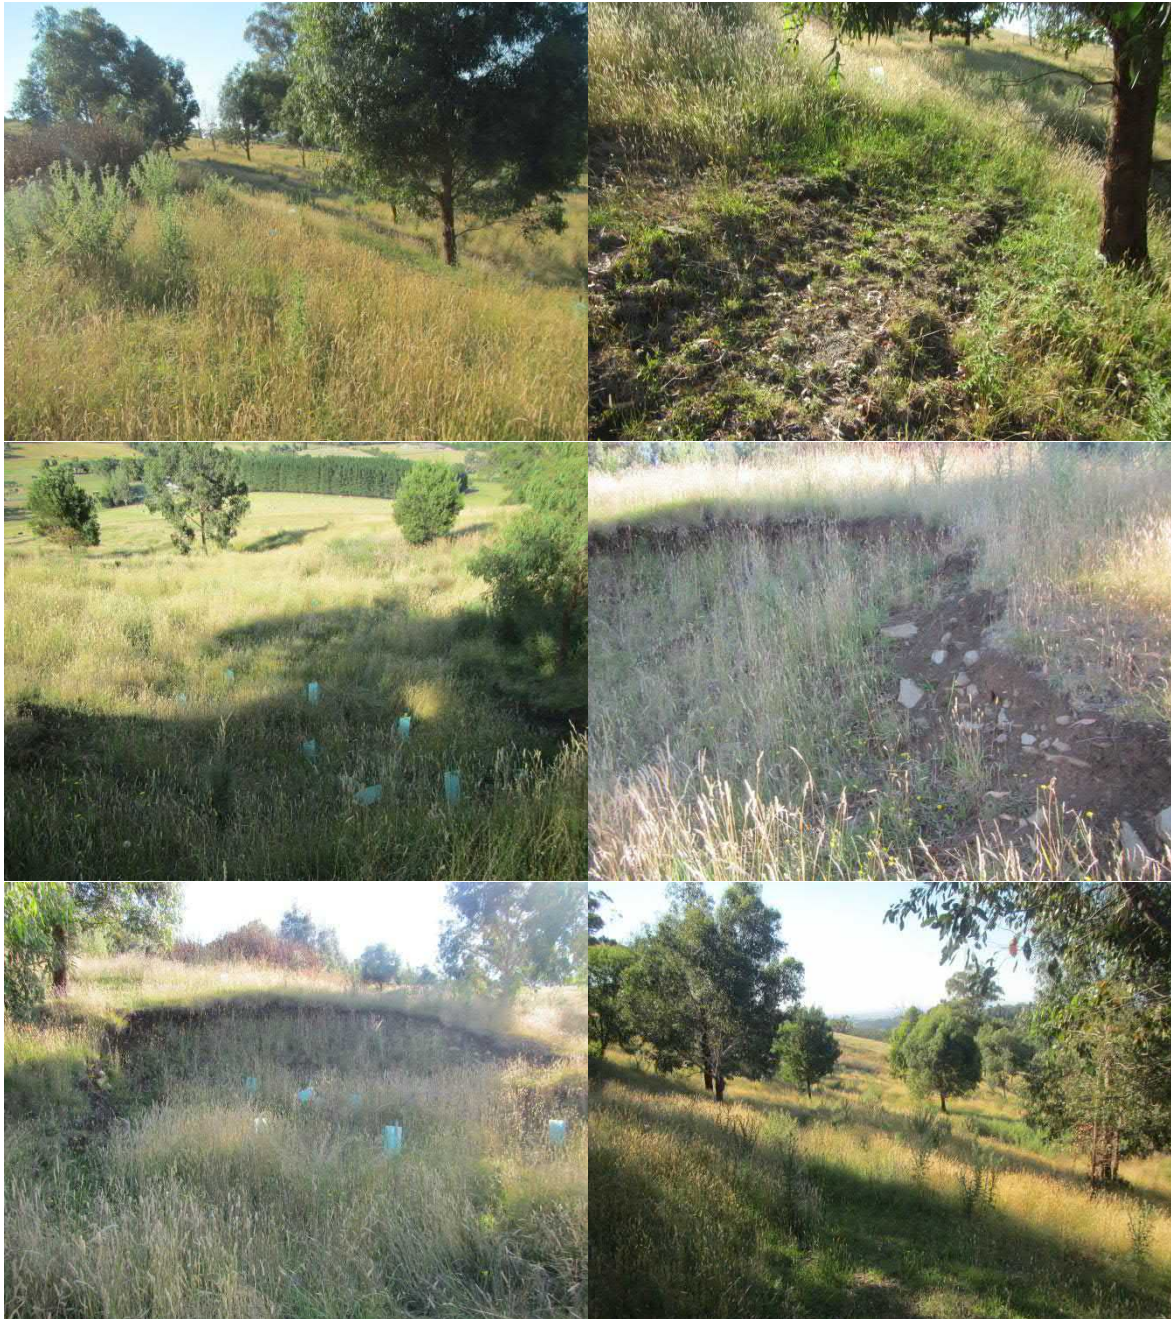
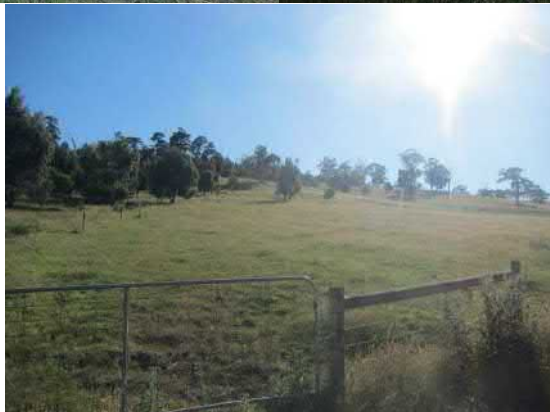
**Mass04**

- Mass04: During the 2017 review period, a small landslip has occurred within the larger Mass04 area. Remediation works in the form of fencing on all sides to prevent animal access to the area, and revegetation behind the failure/ old backscarp and in the saturated area below the failure has been undertaken. No revegetation of the slump surface with grasses was observed; and

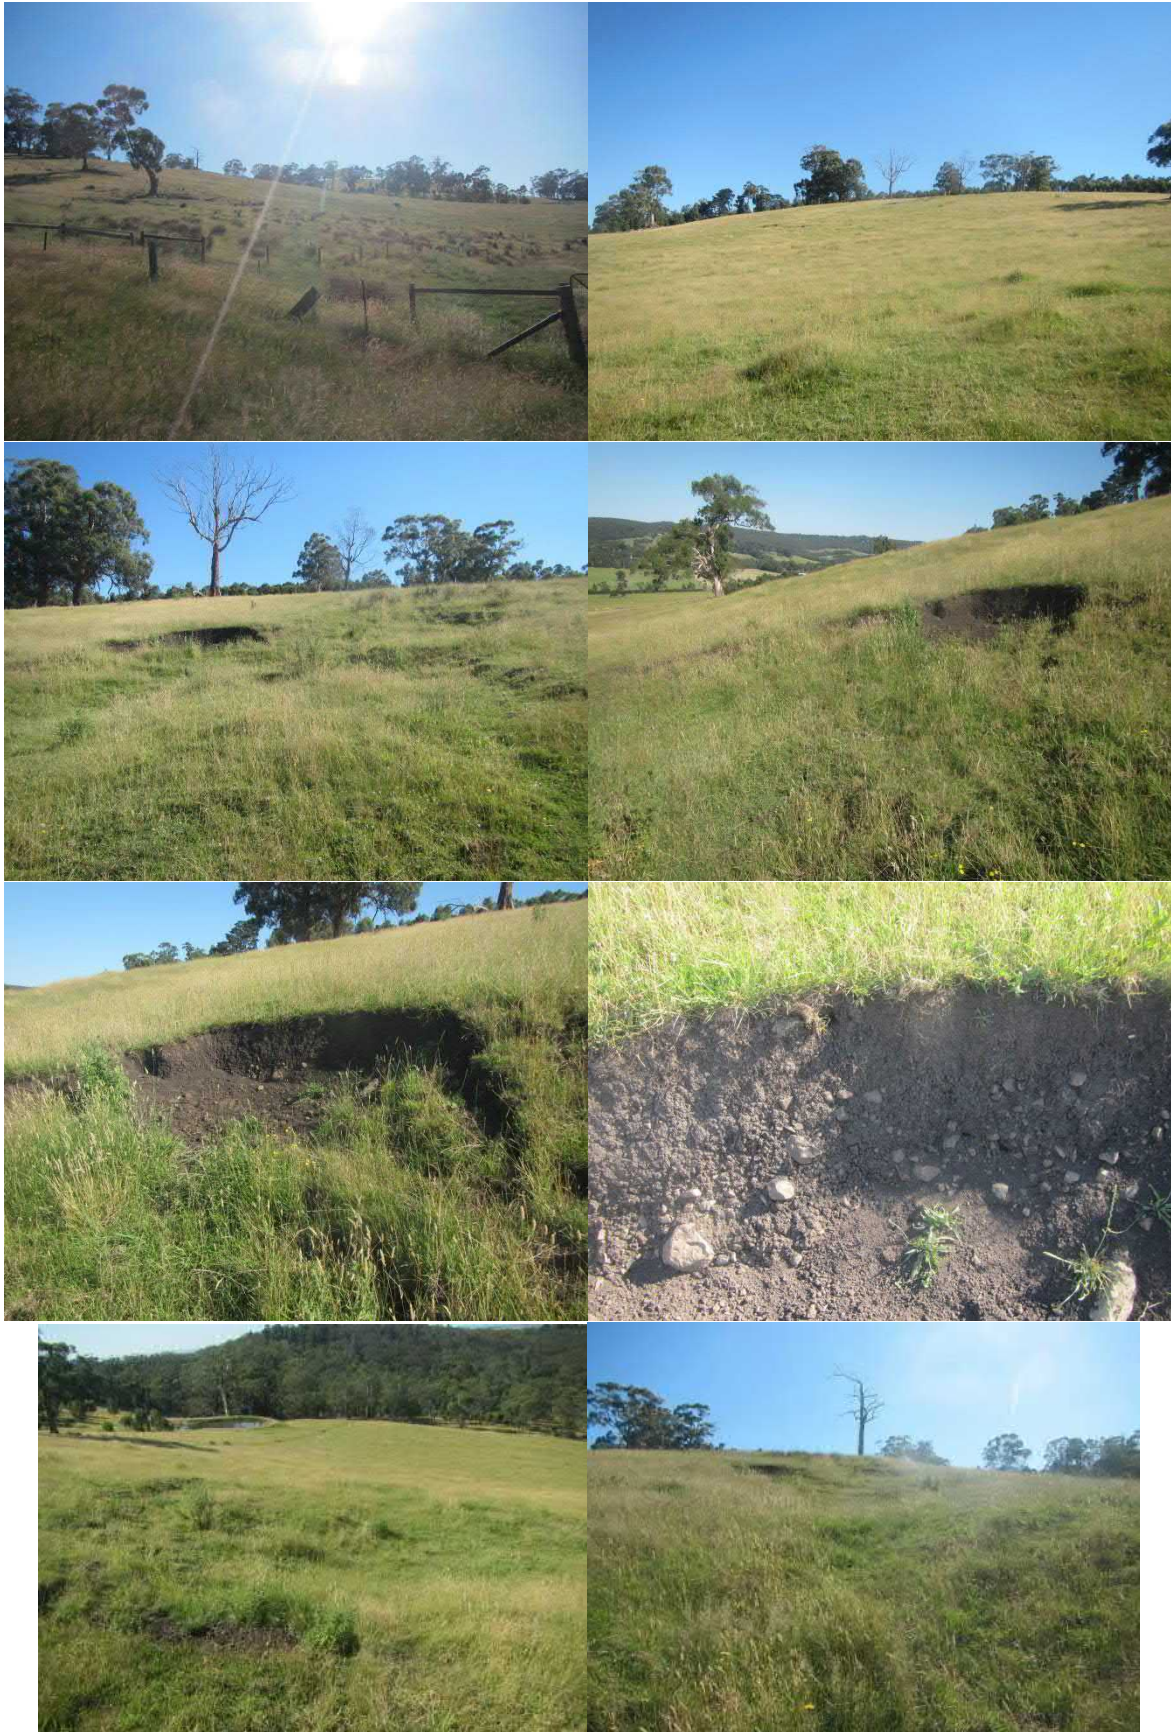
**Mass05**

Landslide Reference ID	2018 Visual Observation
Mass05	<ul style="list-style-type: none"> <li>Overall the area is well vegetated with dense grass cover throughout.</li> <li>Holcim representative indicated that there is no known slope movement in this area over the review period and in general the area is considered to have remained stable over the last 7 years.</li> <li>Minor historical circular failures were observed in three locations: these failures were observed to be associated with exposed (bare) scarps and a change in the natural topography locally downslope with remnant mobilised material. A natural drain has formed through this material to avoid the local high. It is recommended that the bare scarp areas are grassed to mitigate potential of further erosion;</li> <li>The mobilised material is well vegetated. Observation of the exposed scarp suggests that the material is weakly structured, near-surface soil possibly associated with the Werribee Formation (Attachment 1 for geological map and Attachment 2 for photo of scarp)</li> </ul>

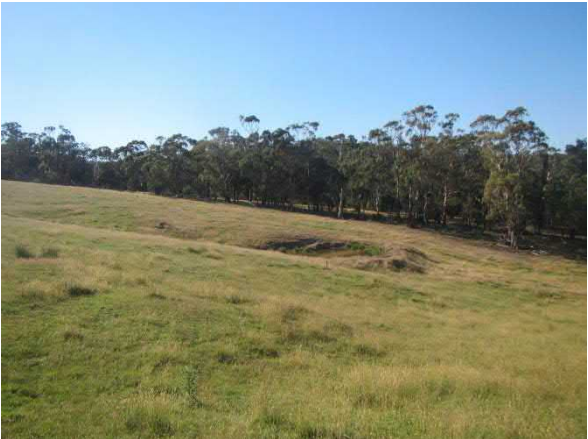
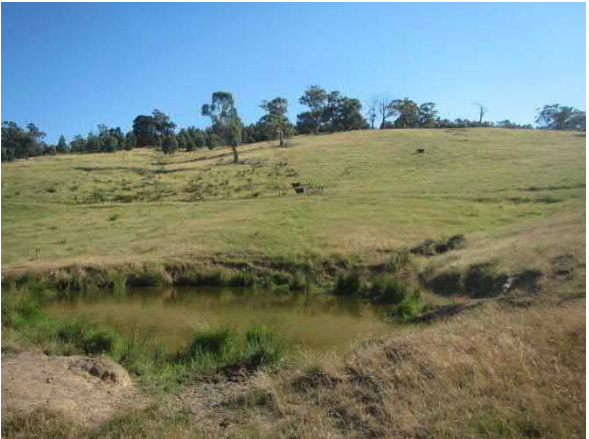
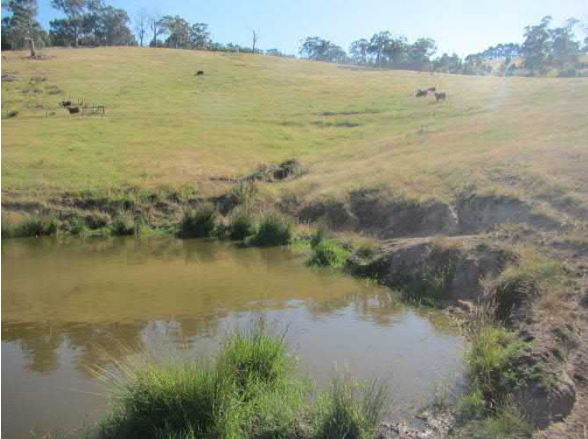
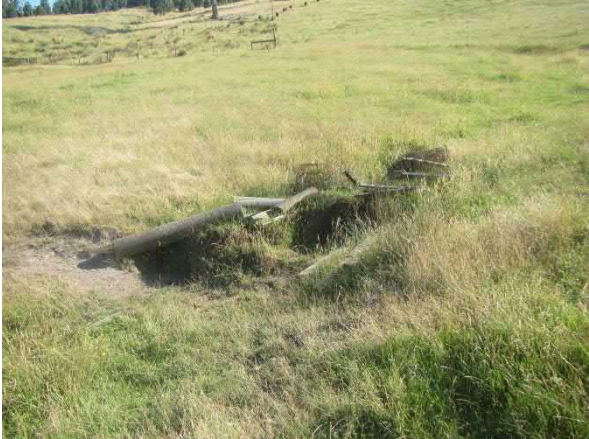
**Mass05 Dam**

Mass05 Dam	<ul style="list-style-type: none"> <li>Upstream drainage channel/ catchment from Mass05 is unobstructed. Embankments are vegetated. Eastern side is bare with an observed retreating crest. There is waste (rubbish) blocking the upstream channel to the east;</li> <li>A downstream spillway has formed naturally; and</li> <li>Water was observed 500mm below the crest of the dam, with the crest material softened by cattle traffic. There is a low risk for this structure in terms of both likelihood and consequence</li> </ul>
Mass06	<ul style="list-style-type: none"> <li>Overall the area is well vegetated with dense grass cover throughout.</li> <li>Holcim representative indicated that there is no known slope movement in this area over the review period and in general the area is considered to have remained stable over the last 7 years</li> </ul>
Mass06 Dam	<ul style="list-style-type: none"> <li>This dam contains a comparatively large volume of water to other dams (surface area 45 m<sup>2</sup>, total depth unknown). The water level was observed at 500mm below the crest;</li> <li>A natural overflow to east has been identified, which directs water to a dam on an adjacent property downstream;</li> <li>The dam crests are retreating with characteristically erosive material. A visual assessment indicates a low risk of failure;</li> <li>Risk to cattle adjacent to dam, where in some places a 1.5-2m vertical difference was observed due to the retreating crest.</li> </ul>

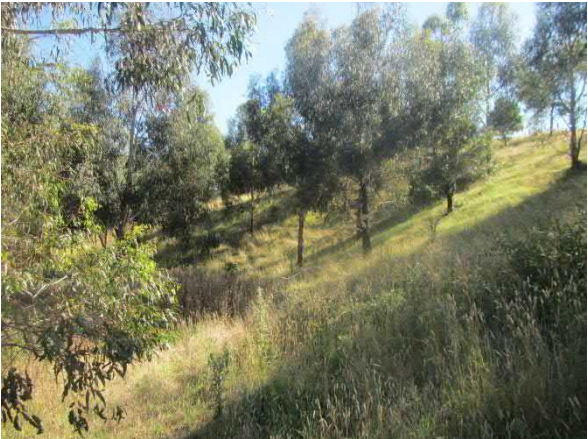
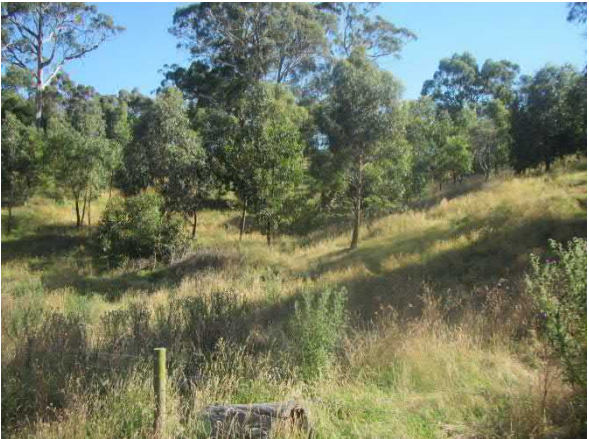
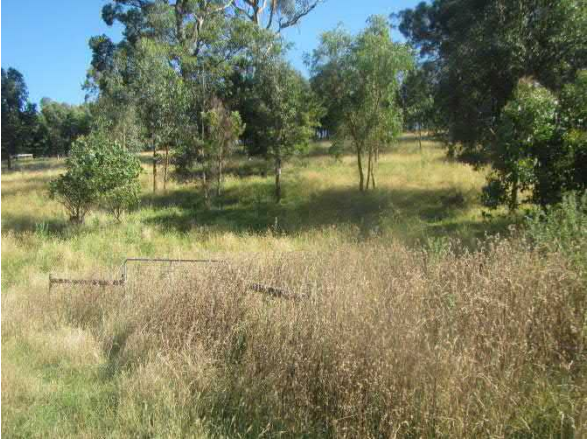
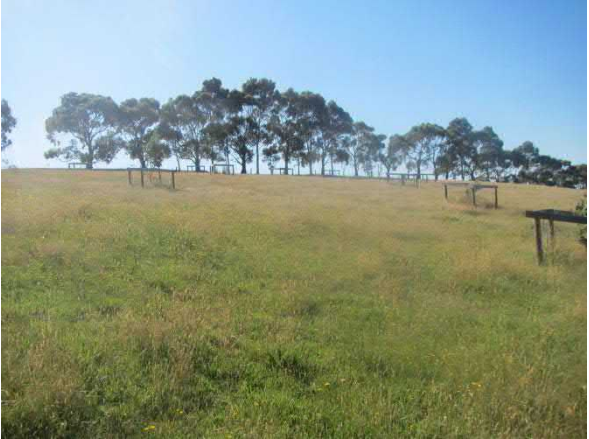
**Mass07**

Mass07	<ul style="list-style-type: none"> <li>Tree planting has been undertaken upstream;</li> <li>There is a minor scarp adjacent to the worn cattle track on the eastern side, suggested erosive driver being the cattle traffic but reiterating the poor structure of the soils;</li> <li>Historical scarp has been vegetated with no exposed ground or evidence of movement. Overall the area is well vegetated with dense grass cover throughout;</li> <li>Holcim representative indicated that there is no known slope movement in this area over the review period and in general the area is considered to have remained stable over the last 7 years</li> </ul>
Mass08	<ul style="list-style-type: none"> <li>Overall the area is well vegetated with dense grass cover throughout;</li> <li>There are some historical scarps up to 1m height. These demonstrate weak soil structure, with anticipated minor failures in rain events;</li> <li>The local area immediately below scarp is poorly vegetated; and</li> <li>A minor, unrelated scarp was observed upstream.</li> </ul>

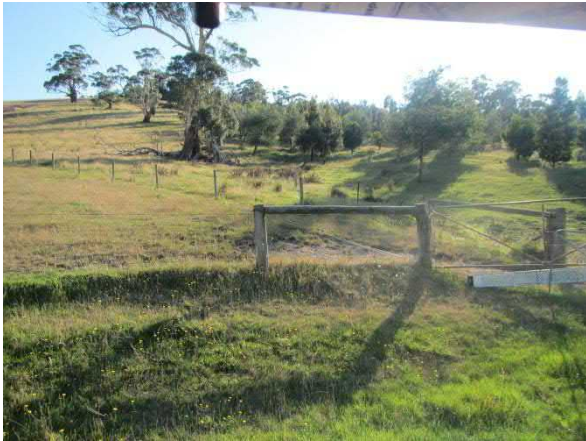
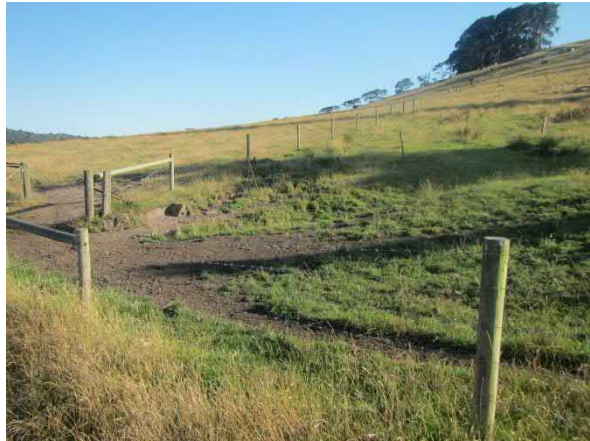
**Mass09**

Mass09	<ul style="list-style-type: none"> <li>Overall the area is well vegetated with dense grass cover and small to medium shrubs and trees throughout.</li> <li>Whilst the slope surface is hummocky, this appears to be associated with historical major landslips and no evidence of recent or ongoing instability was observed (exception being small circular failure of old back scarp, as discussed below).</li> <li>Holcim representative indicated that there is no known slope movement in this area over the review period and in general the area is considered to have remained stable over the last 7 years.</li> </ul>
Mass10	<ul style="list-style-type: none"> <li>Overall the area is well vegetated with dense grass cover and medium shrubs and trees throughout.</li> <li>Whilst the slope surface is hummocky, this appears to be associated with historical major landslips and no evidence of recent or ongoing instability was observed (exception being small circular failure of old back scarp, as discussed below).</li> <li>Holcim representative indicated that there is no known slope movement in this area over the review period and in general the area is considered to have remained stable over the last 7 years.</li> <li>Minor grass cover has been removed with bare earth exposed – surficial erosion only.</li> <li>Minor downstream surficial erosion;</li> <li>A drain was observed under road to the south of the mass. No blockage observed at entry/ exit.</li> </ul>

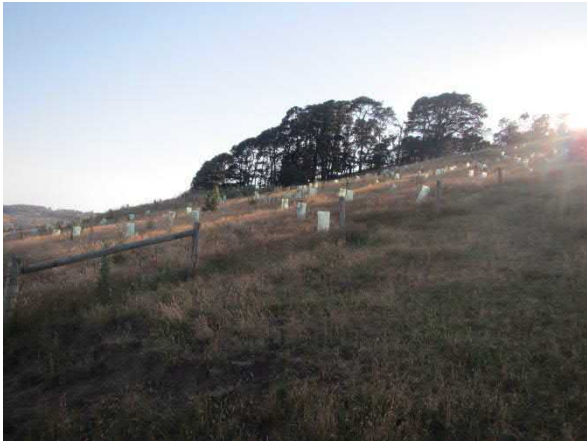
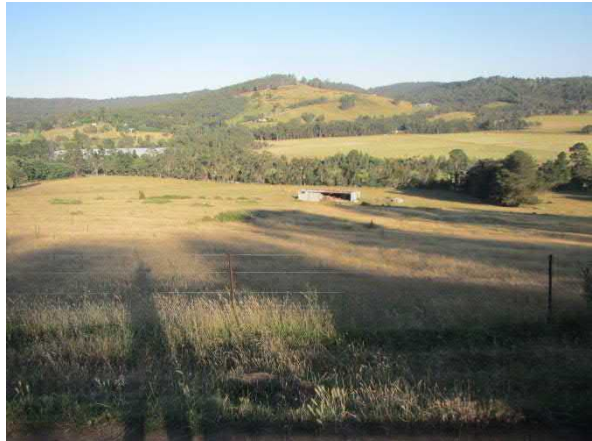
**Mass11**

Mass11	<ul style="list-style-type: none"> <li>Overall the area is well vegetated with dense grass cover and shrub and tree planting program, on a tight grid, has been established (refer Attachment 2).</li> <li>Whilst the slope surface is hummocky, this appears to be associated with historical major landslips and no evidence of recent or ongoing instability was observed (exception being small circular failure of old back scarp, as discussed below).</li> <li>A small area in the top north corner of the Mass is bare of grass cover, however this does not appear to represent slope instability and the area has been revegetated since the 2017 inspection. .</li> <li>Holcim representative indicated that there is no known slope movement in this area over the review period and in general the area is considered to have remained stable over the last 7 years.</li> </ul>
Mass12	<ul style="list-style-type: none"> <li>Overall the area is well vegetated with dense grass cover and medium shrubs and trees throughout.</li> <li>Whilst the slope surface is hummocky, this appears to be associated with historical major landslips and no evidence of recent or ongoing instability was observed (exception being small circular failure of old back scarp, as discussed below).</li> <li>Holcim representative indicated that there is no known slope movement in this area over the review period and in general the area is considered to have remained stable over the last 7 years.</li> </ul>

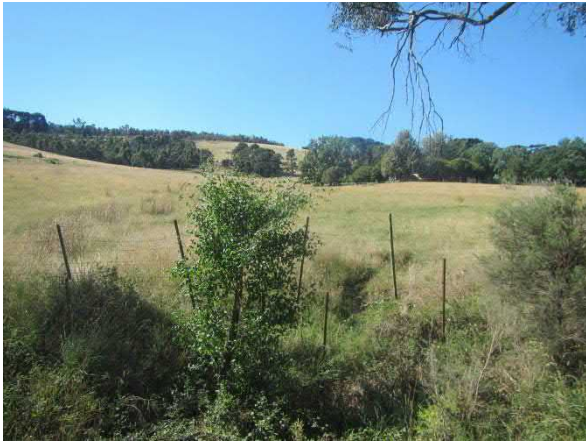
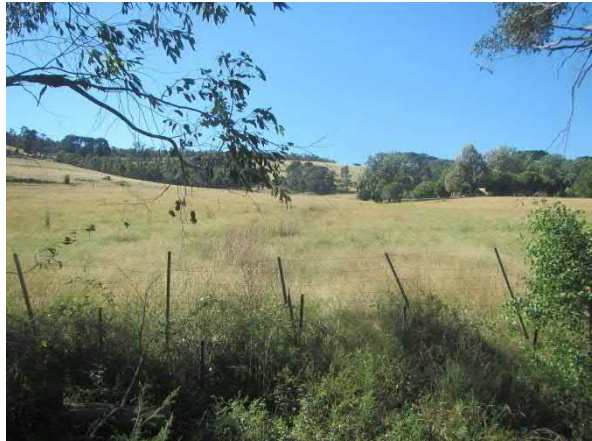
**Mass14**

Mass14	<ul style="list-style-type: none"> <li>Overall the area is well vegetated with dense grass cover and medium shrubs and trees throughout.</li> <li>Whilst the slope surface is hummocky, this appears to be associated with historical major landslips and no evidence of recent or ongoing instability was observed (exception being small circular failure of old back scarp, as discussed below).</li> <li>Holcim representative indicated that there is no known slope movement in this area over the review period and in general the area is considered to have remained stable over the last 7 years.</li> </ul>
Mass15	<ul style="list-style-type: none"> <li>Overall the area is well vegetated with dense grass cover and medium shrubs and trees throughout.</li> <li>Whilst the slope surface is hummocky, this appears to be associated with historical major landslips and no evidence of recent or ongoing instability was observed (exception being small circular failure of old back scarp, as discussed below).</li> <li>Holcim representative indicated that there is no known slope movement in this area over the review period and in general the area is considered to have remained stable over the last 7 years.</li> <li>Minor side-road scarps were observed, anticipated due to cattle traffic;</li> <li>John Everitt anecdotally shared that there is a spring present under the large tree at the elevated east of this mass.</li> </ul>

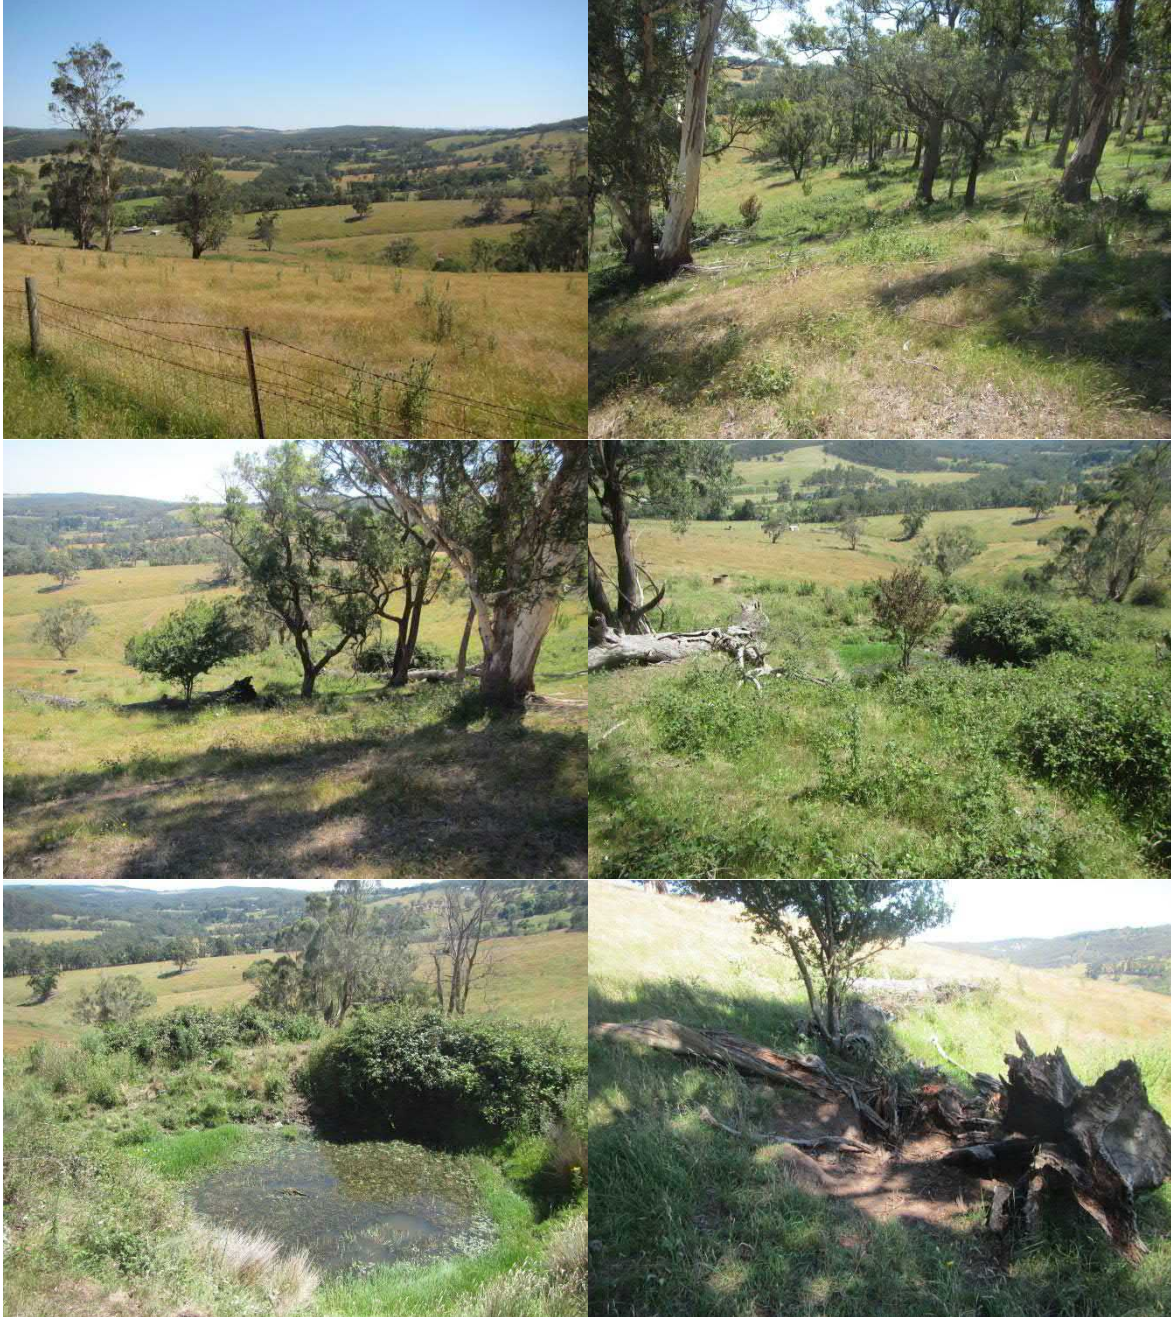
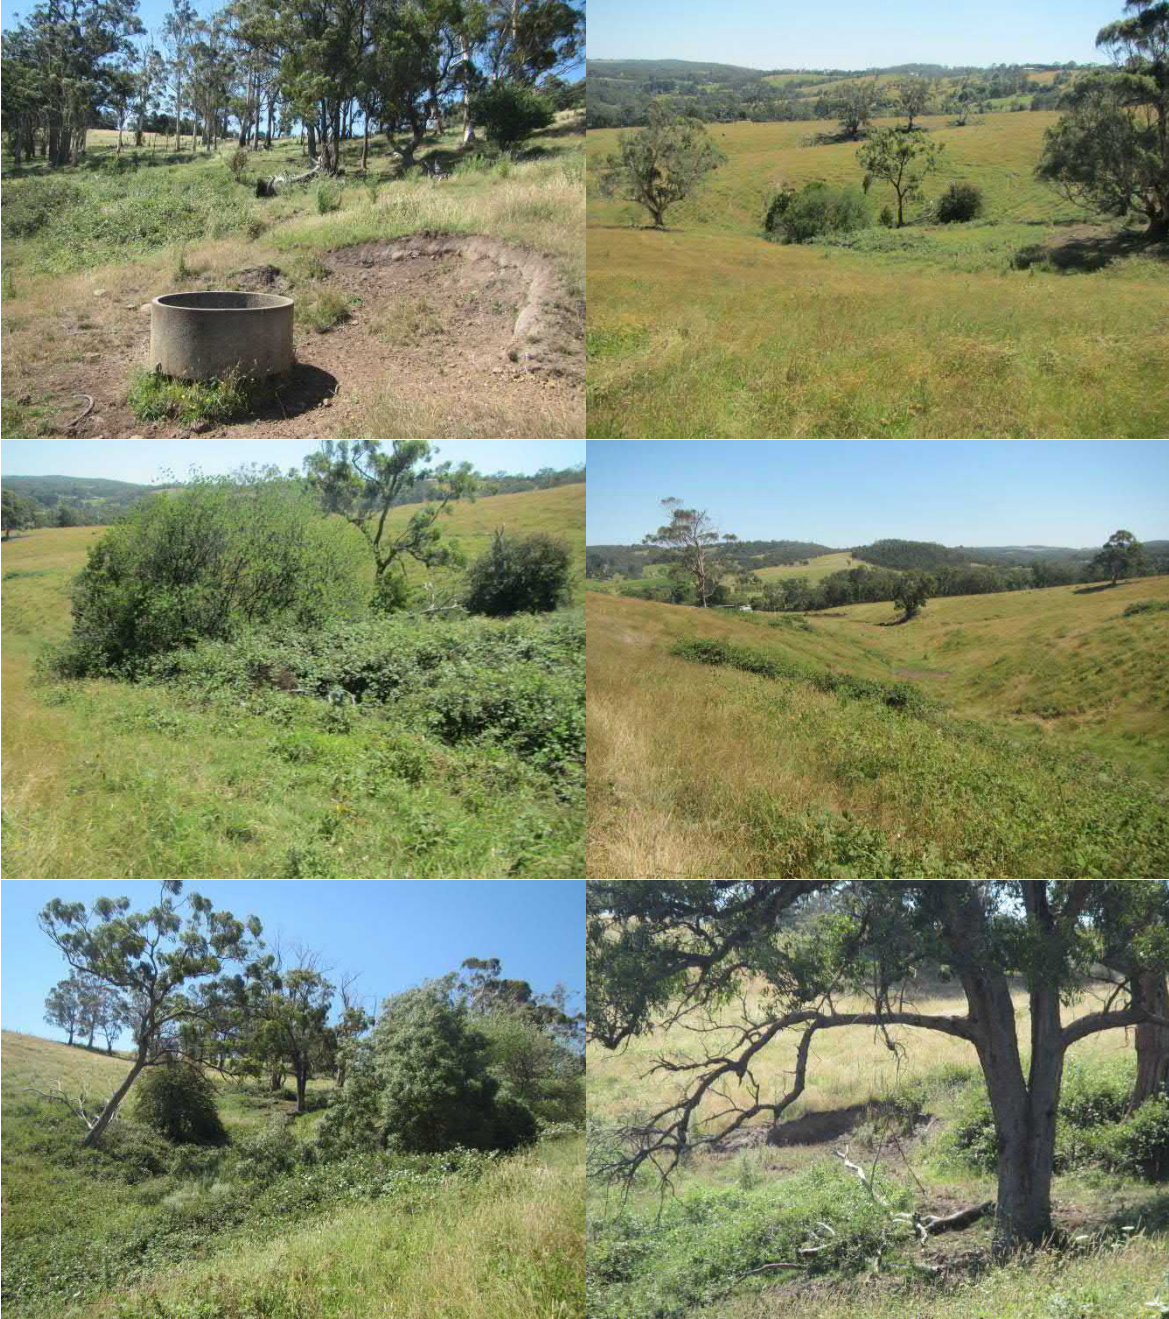
**Mass16**

Mass16	<ul style="list-style-type: none"> <li>Access gained to site but noted that it is important to contact landowner prior to entering.</li> <li>Heavy vegetation in the northern area, predominantly trees but reeds observed as dense nearer the waterway. There is minor side slope erosion visible but anticipated to be related to traffic (both vehicles and cattle).</li> <li>A minor farm dam was observed approximately halfway up the mass. Very heavy vegetation. The water level was observed 1.5m from crest of the dam with minor cattle tracks observed on the crest.</li> </ul>
Mass17	<ul style="list-style-type: none"> <li>Area is well vegetated with dense grass cover</li> <li>Whilst the slope surface is hummocky, this appears to be associated with historical major landslips and no evidence of recent or ongoing instability was observed.</li> <li>Holcim representative indicated that there is no known slope movement in this area over the review period and in general the area is considered to have remained stable over the last 7 years.</li> </ul>

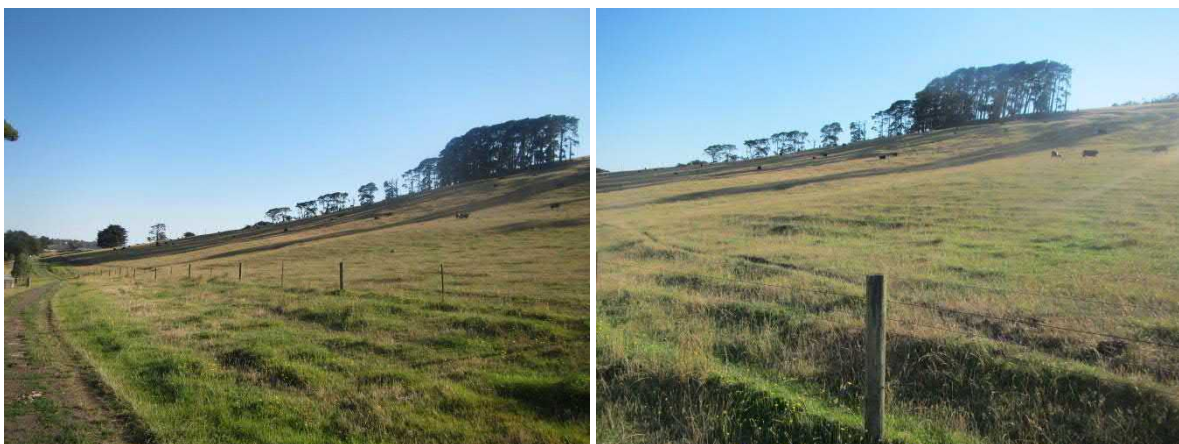
**Mass18**

Mass18	<ul style="list-style-type: none"> <li>Overall the area is well vegetated with dense grass cover and medium shrubs and trees throughout.</li> </ul>
Mass19	<ul style="list-style-type: none"> <li>Whilst the slope surface is hummocky, this appears to be associated with historical major landslips and no evidence of recent or ongoing instability was observed (exception being small circular failure of old back scarp, as discussed below).</li> </ul>
Mass20	<ul style="list-style-type: none"> <li>Holcim representative indicated that there is no known slope movement in this area over the review period and in general the area is considered to have remained stable over the last 7 years.</li> </ul>

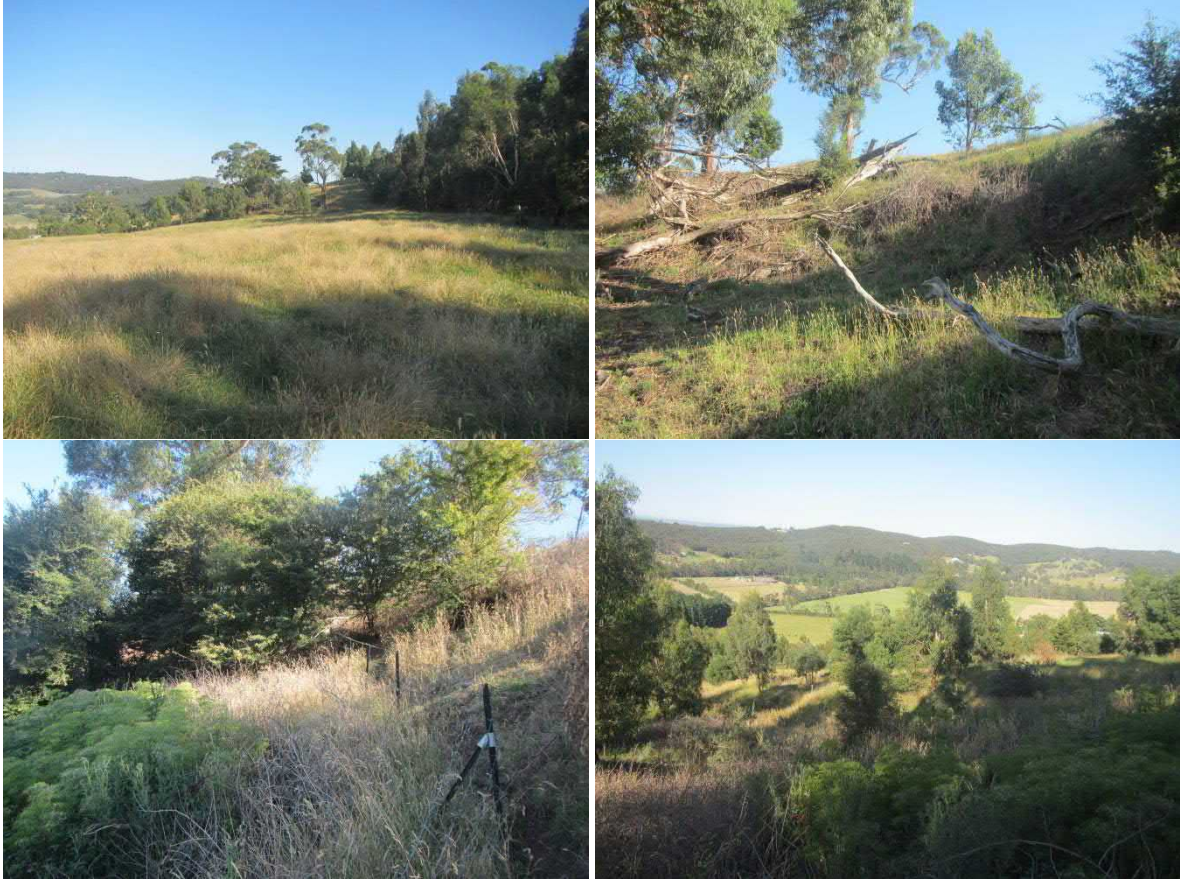
**Intermediate scarp to northeast of Mass09, Mass02, and Mass03**

Landslide Reference ID	2018 Visual Observation
Other Areas Visited	
Back scarp of Large Historical Landslide comprising Masses 1, 2, 3, 9 and 17	<ul style="list-style-type: none"> <li>• While the back scarp was not located on this investigation, an intermediate scarp was observed approximately ¾ of the way upslope toward the rear of the scarp.</li> <li>• This area is well vegetated with grasses and trees. The back scarp of the old large landslide is still visible however no evidence of recent or ongoing movement was observed.</li> </ul>
