# Mt Shamrock Environmental Management Plan - 3 Monthly Progress Update

**April 2021 - June 2021**

Prepared by Matt Dodd for Mt Shamrock Quarry Environmental Review Committee

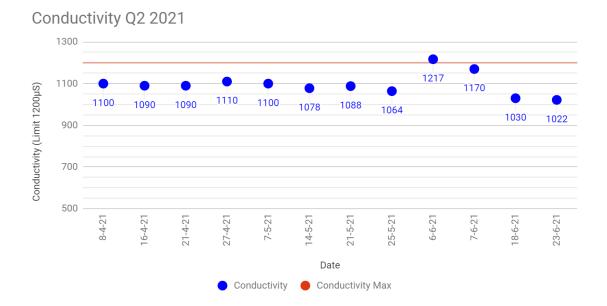
# Conductivity – A measure of the water's capability to pass electrical current. Limit 1200µS

- In May, 1 Truck went down Mt Shamrock road with the Tarp not fully closed. It was noticed immediately and the driver addressed this.
- 6th June, Conductivity test result at V-Notch returned a result of 1217, license limit is 1200. The EPA were notified, no actions required.

As noted earlier, the result on the 6th June exceeded the prescribed license limit of 1200. This was reported to the EPA with no actions required.

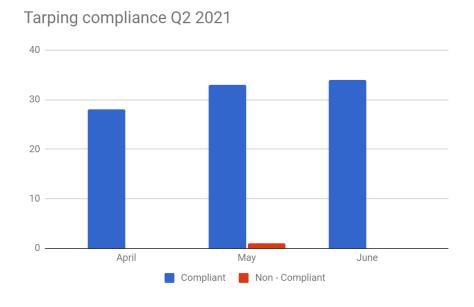
# **Graph showing Tarping visual checks**

In May, 1 truck went down Mt Shamrock Road with its tarp only partially on, This was corrected immediately by the driver.
