6 February 2019

Matt Dodd
Quarry Manager- Pakenham
Holcim (Australia) Pty Ltd
95 Mount Shamrock Road, Pakenham

2018 Groundwater and Spring Review, Pakenham Quarry

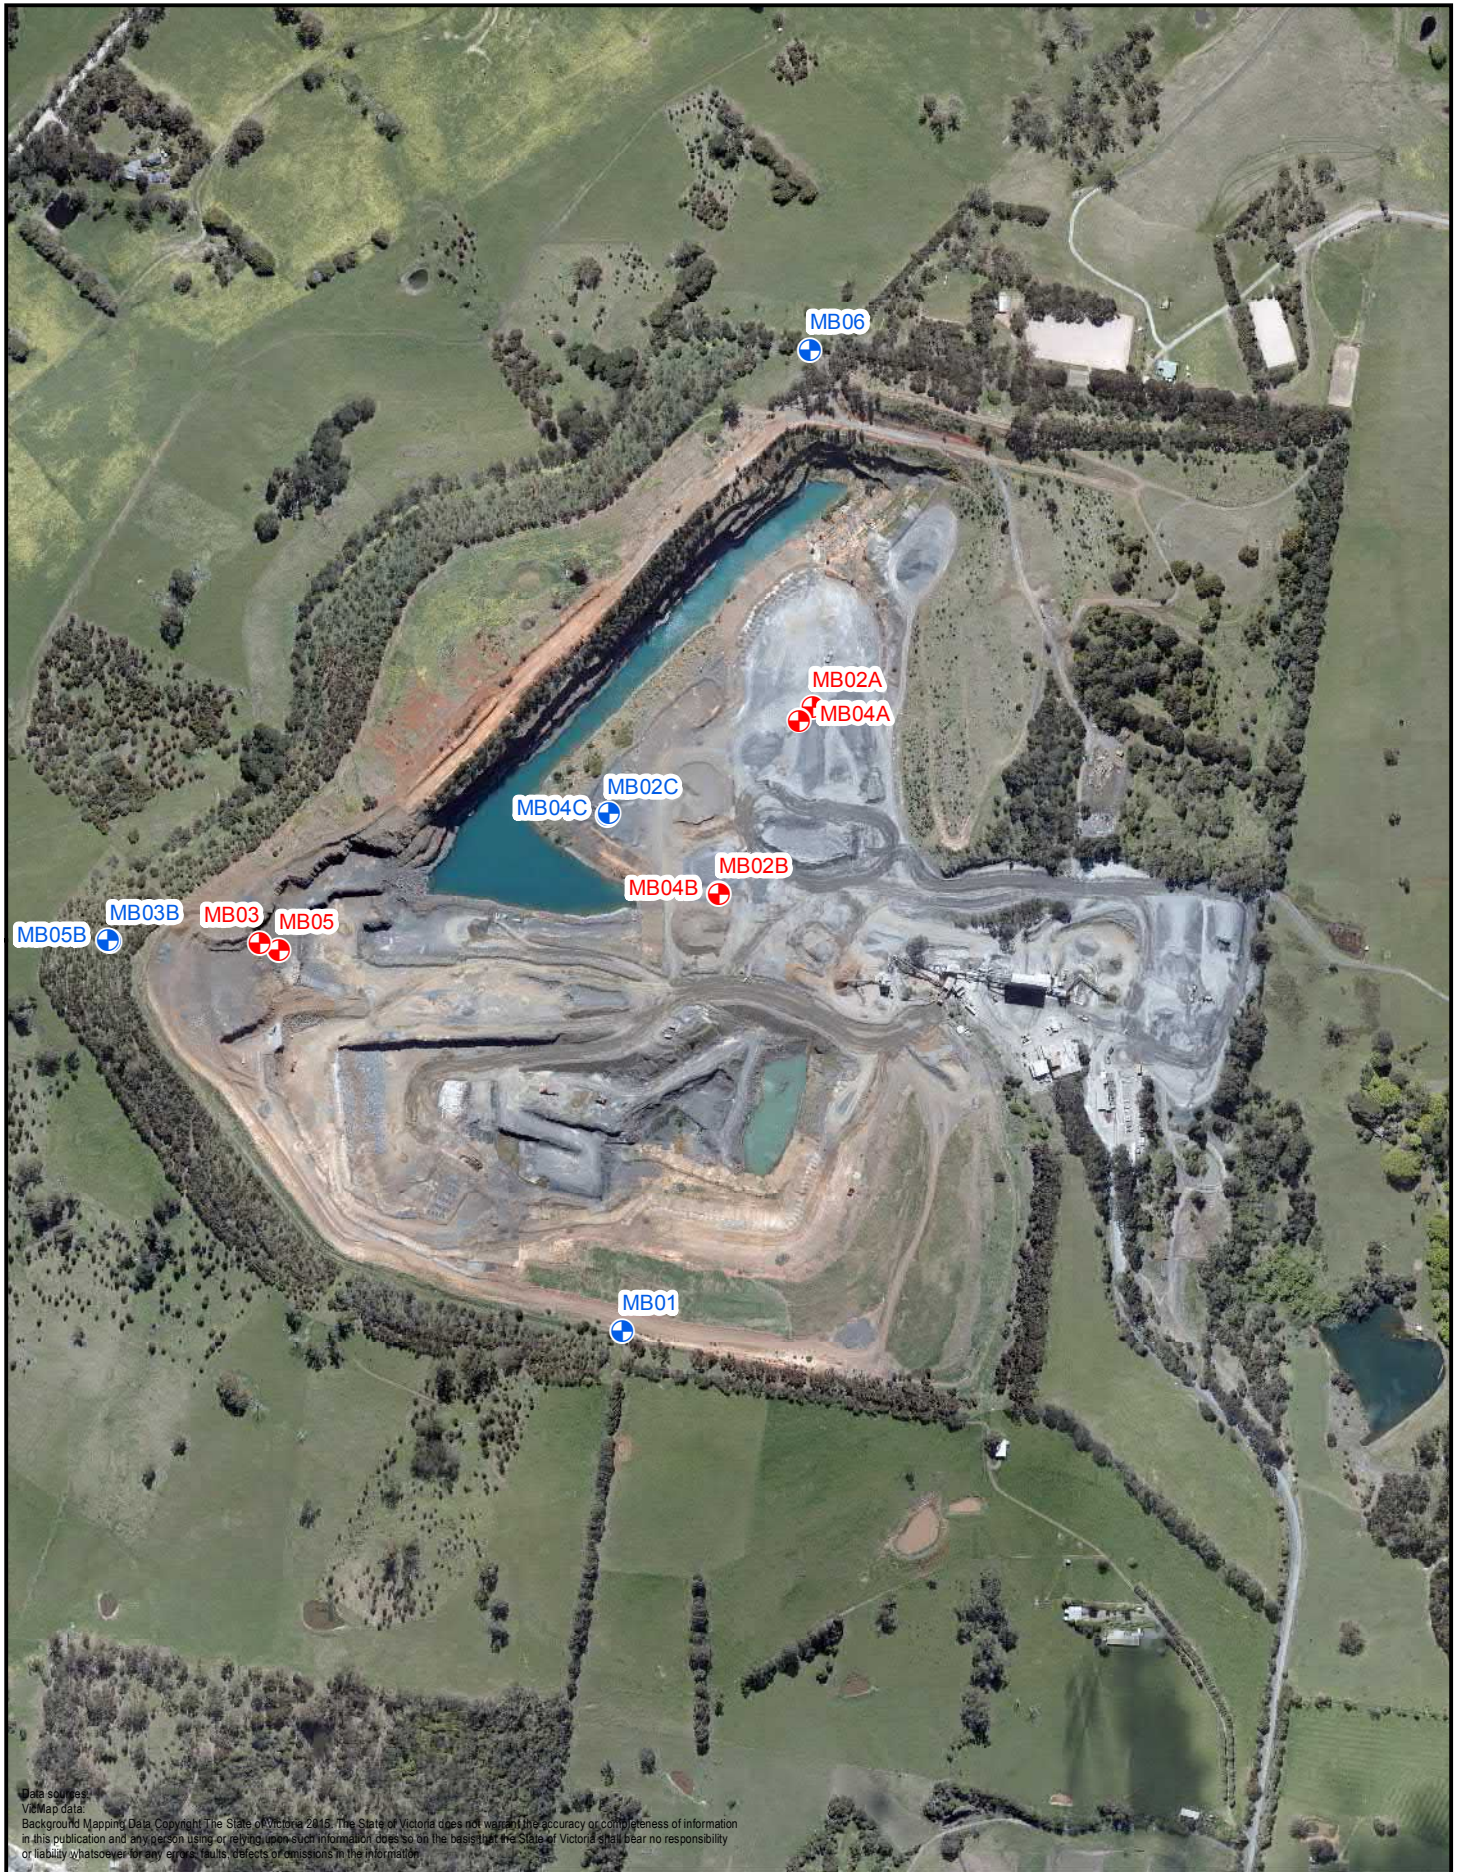
Figure 2

It is noted that the groundwater monitoring locations included on Appendix 11- Figure 1 in the EMP were replaced in October 2014, and a revised groundwater monitoring network now exists to replace bores lost (refer to **Attachment 1- Figure 2** for current groundwater monitoring bore locations).

The bore network gauged during 2018 is presented on **Attachment 1- Figure 2**.

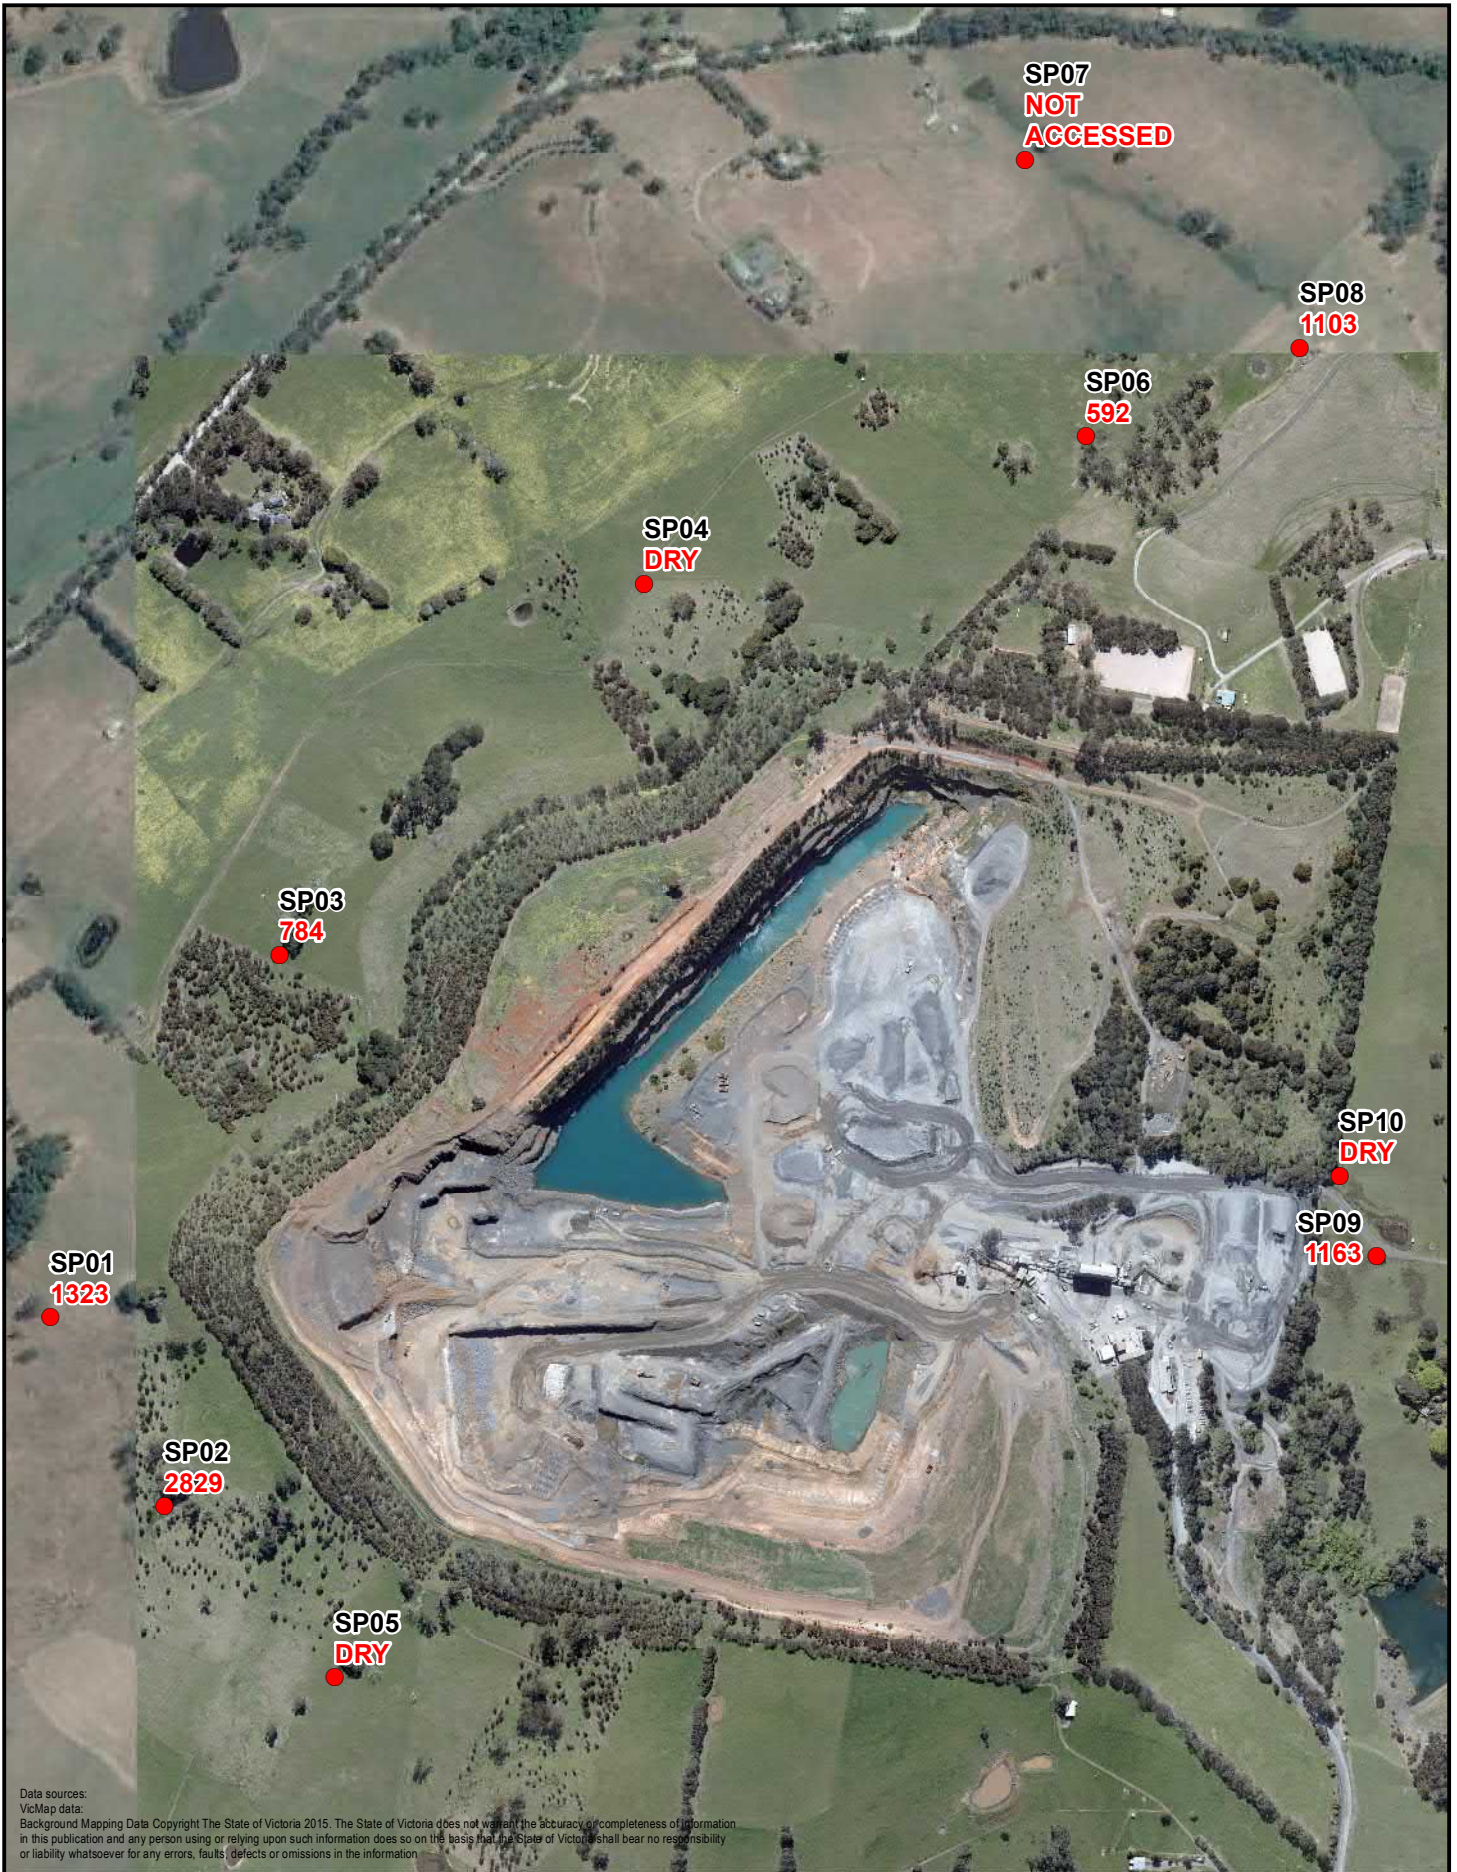
It is noted that during the 2014 survey two of the mapped springs (SP09 & SP10) were not considered to be discrete groundwater discharge points due to significant surface water and seepage influences and/or changes in topography and infrastructure at the site. The locations of all mapped seepages/springs/water catchments are presented in **Attachment 1- Figure 3**.

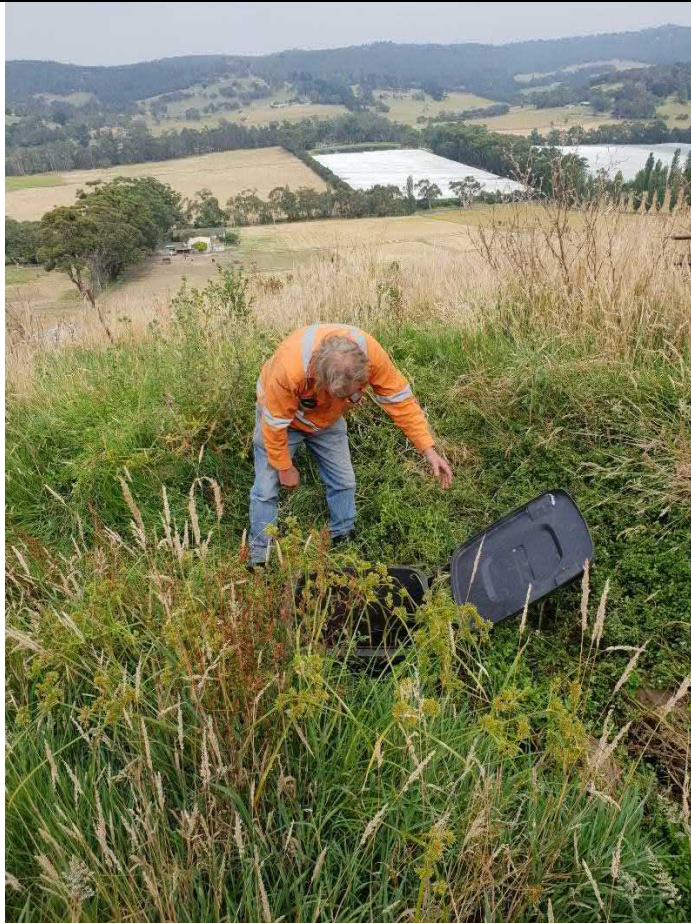
Plate 1
Spring 1

SP01 located to the west of the quarry site, provides irrigation and stock water to a number of properties in the local area. The area was observed to be boggy and vegetation in good health.

In January 2019, the flow at SP01 was observed at approximately 2.25L/min. Previous observations in 2017 note a flow rate of approximately 1.5L/min, about 4L/min in 2015, about 5L/min in 2014 and approximately 6 L/min in June 2013.

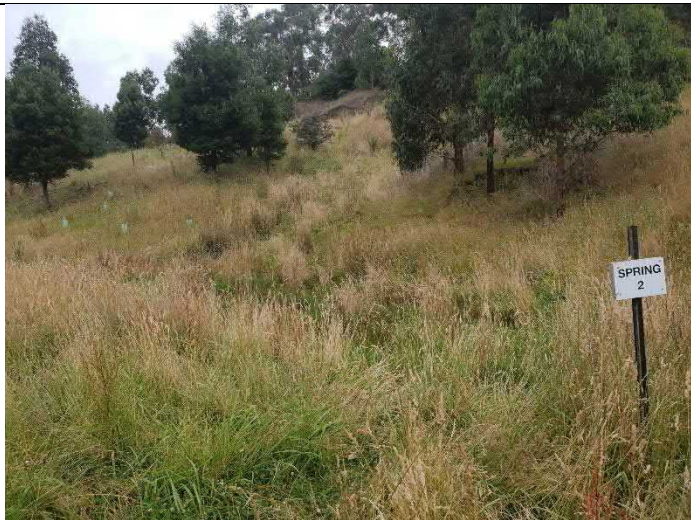
Plate 2
Spring 2

SP02 located to the west of the quarry, was observed to be a small dam feed by groundwater and surface water runoff from a relatively steep slope above. The area was fenced, with no flow measured.

The dam exhibits instability on the downslope face. It was previously understood that under heavy rainfall, the pond overtops resulting in erosion and instability on the face of the dam. The spring was noted to have the potential to break free of the wall constructed at the location to reduce flow down the slope. A tank is apparently planned to be constructed downgradient from which water is fed to, to reduce stress on the wall.

In January 2019 the the spring was noted to be a deep pond with a large amount of duckweed and overgrown grass. Although no flow was observed, troughs and tanks in the area were full. No evidence of new seeps was noted.

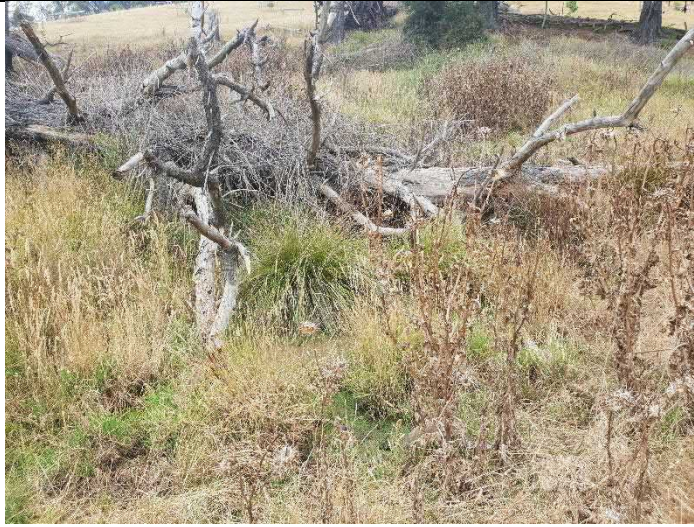
Plate 3
Spring 3

SP03 contains a concrete lined ponded water outflow and water pooling on the ground from both. Vegetation in January 2019 was very healthy and the surrounding area boggy. Flow was not observed however water troughs full.

Measured EC (784 µS/cm) values were within those historically reported (540-1,022 µS/cm). Following an observed spike in EC in 2016 values have stabilised at a lower level since then.

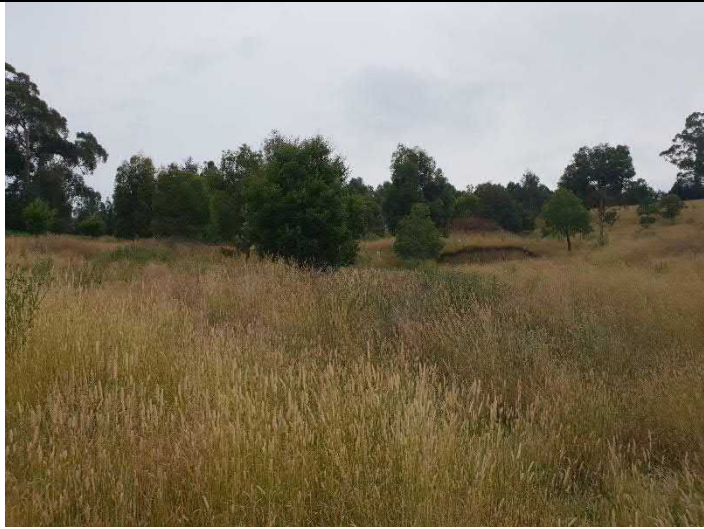
<p>Plate 5 Spring 5</p>
 	<p>Plate 6 Spring 6</p>

In January 2019 the spring was observed to be dry, as it has been since 2009, and water quality measurements could not be collected. Despite the dry spring vegetation was noted to appear healthy and overgrown

Spring water at SP06 accumulates in a collection pond accessible to livestock, with cattle prints observed. Pool at spring was noted to be stagnant and very boggy. The pool is approximately 15-20m² and up to 0.5m deep. EC was measured as 592 $\mu\text{S}/\text{cm}$, within the historical range.

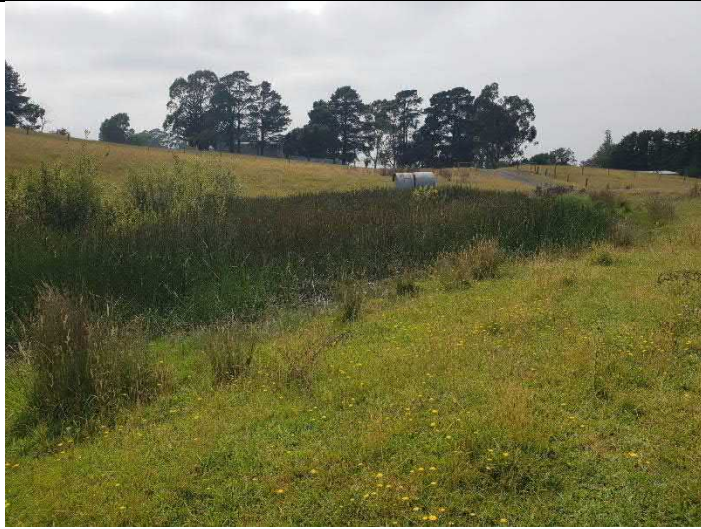
Plate 9
Spring 9

An access road was constructed in the vicinity of SP09 in 2014 and the access road includes a culvert installed underneath that diverts water away from the quarry. The topography of the area was noted to be slightly altered during the construction.

A pond of water was observed down gradient of the former SP09 location that is most likely a combination of seepage and surface water run-off, and is unlikely to have a significant groundwater contribution at the location observed.

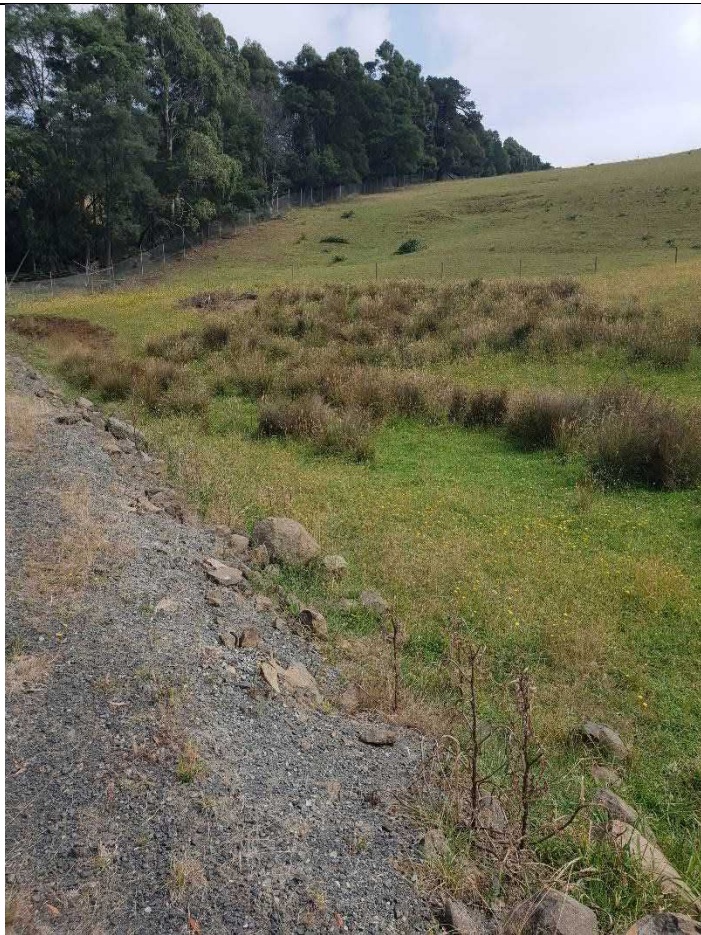
Plate 10
Spring 10

Similar to SP09, the monitoring point, SP10, was noted to be changed by the previous construction of an access road and culvert.
