Quarterly Report

October - December

**Mt Shamrock
Environmental Management Plan
3 Monthly Progress Update**

Prepared for Mt Shamrock Quarry Environmental Review Committee

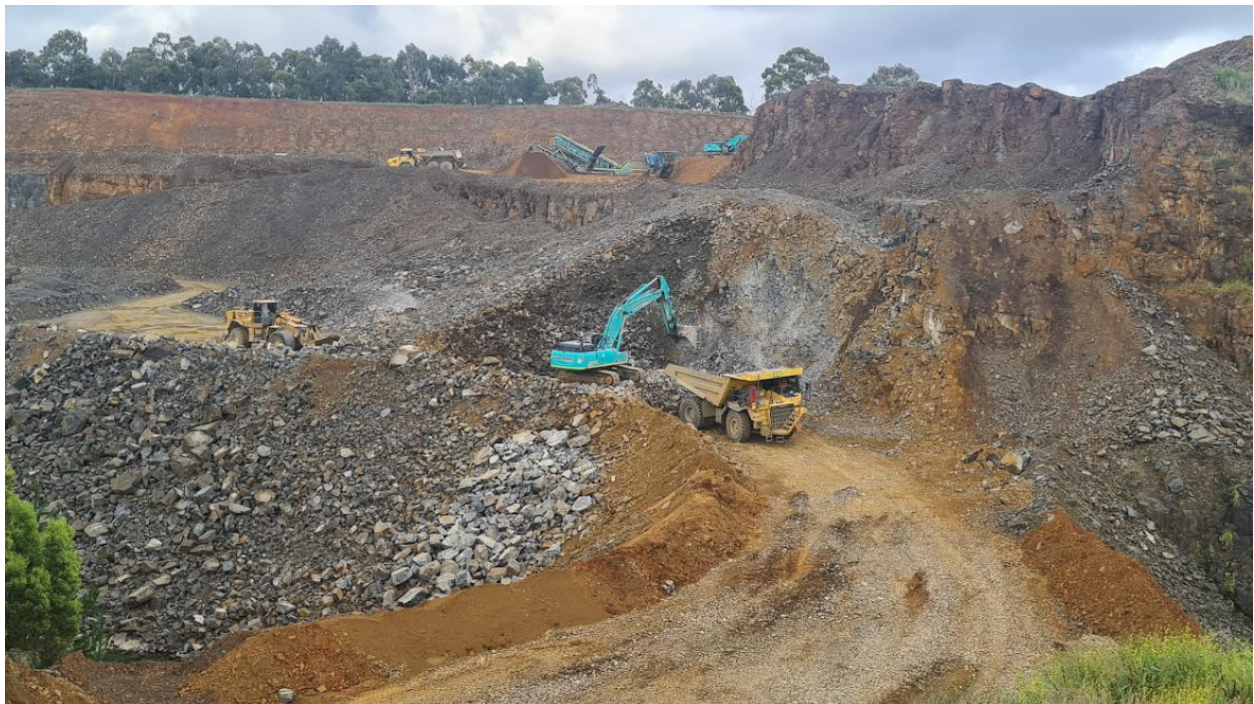
Figure 1 - Image of the new “Land bridge” in operation, November 2022

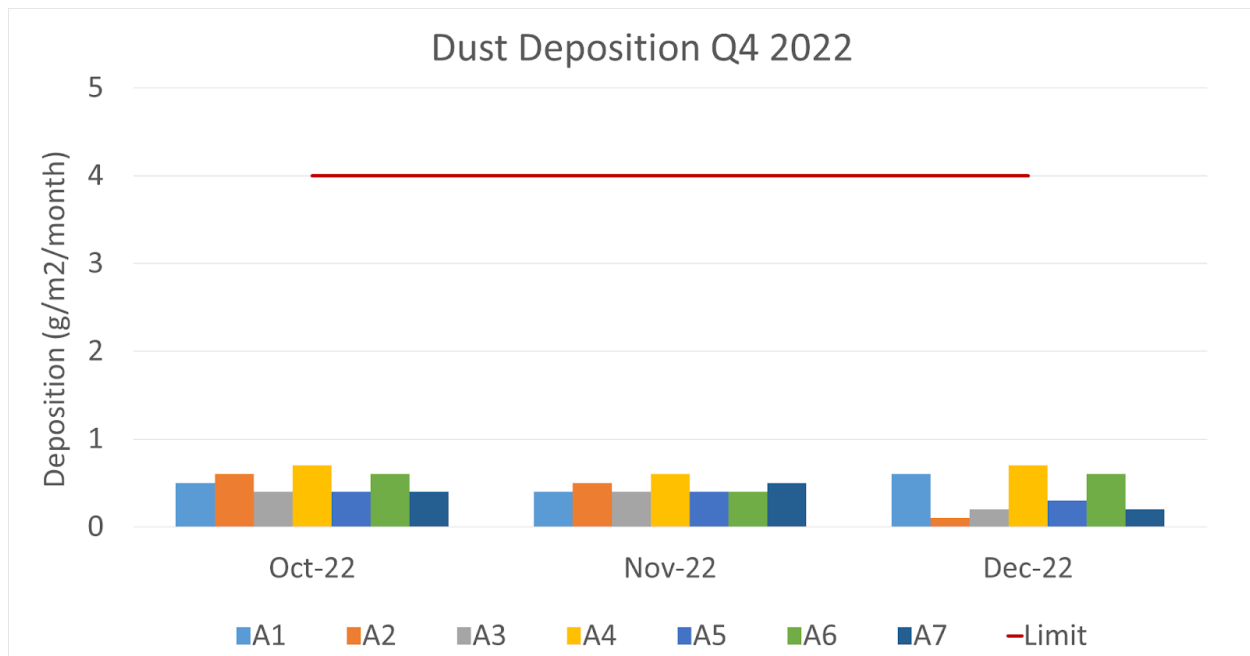
Depositional results have indicated the dust emissions tabulated below. No exceedances during the reporting period.

Figure 2 - Dust Deposition Q4 2022. (Limit 4.0g/m²/mth)

Note that the deposition results presented are Ash analysis test, rather than Total Solids, representing true mineral dust deposition generated by quarry activities.

Deposition bottles are stationed at 7 locations including a background monitoring location at station A7. Particulate matter sampled by this method is predominantly dust particles which, because of their size rapidly settle from the air. Results can be affected by Ash from burning off, bird droppings and insects.

Limit – 4.0gm/m² mth

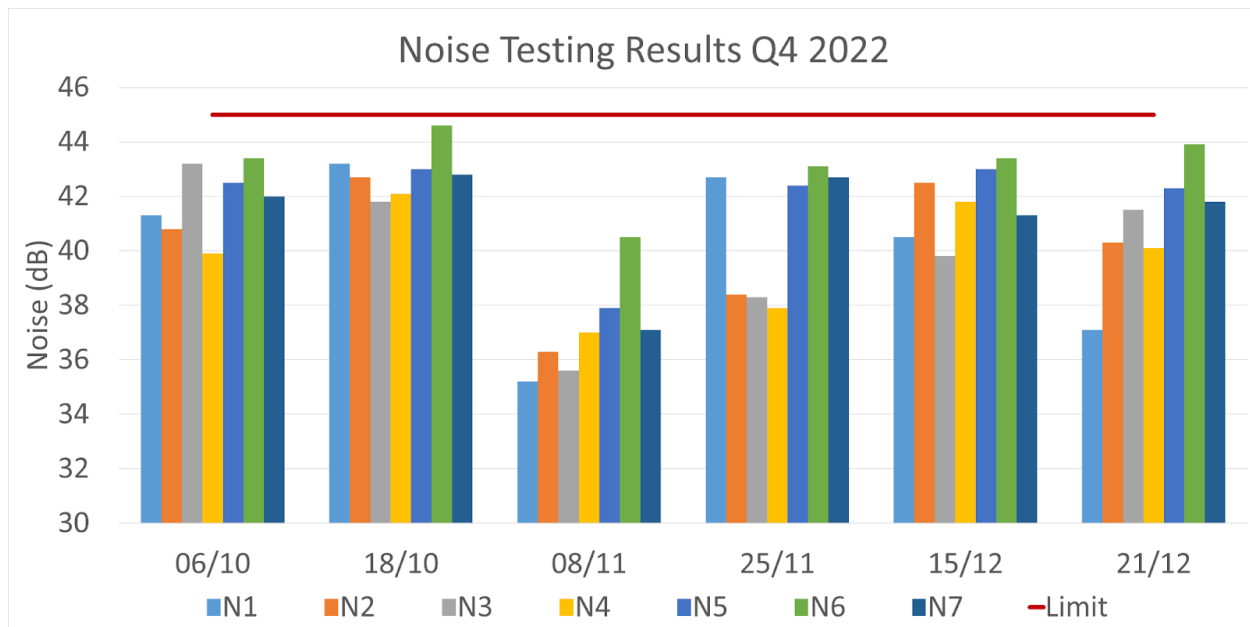
Average noise levels for the 4th Quarter 2022 are shown below. No exceedances during the reporting period.

Figure 3 - Noise Testing Results Q4 2022. (Limit is 45dB under normal operating conditions)

Noise monitoring locations and limits set in the EMP are monitored through the use of a RION hand held monitor. Employees on site who conduct the monitoring are trained and certified in theoretical and practical assessment of the RION hand held meter and basic acoustics.

Limits – 45dB(A) LAeq 7:00 – 18:00 Normal Operation
68dB(A) LAeq 7:00 – 18:00 Noise Attenuation Mound Construction

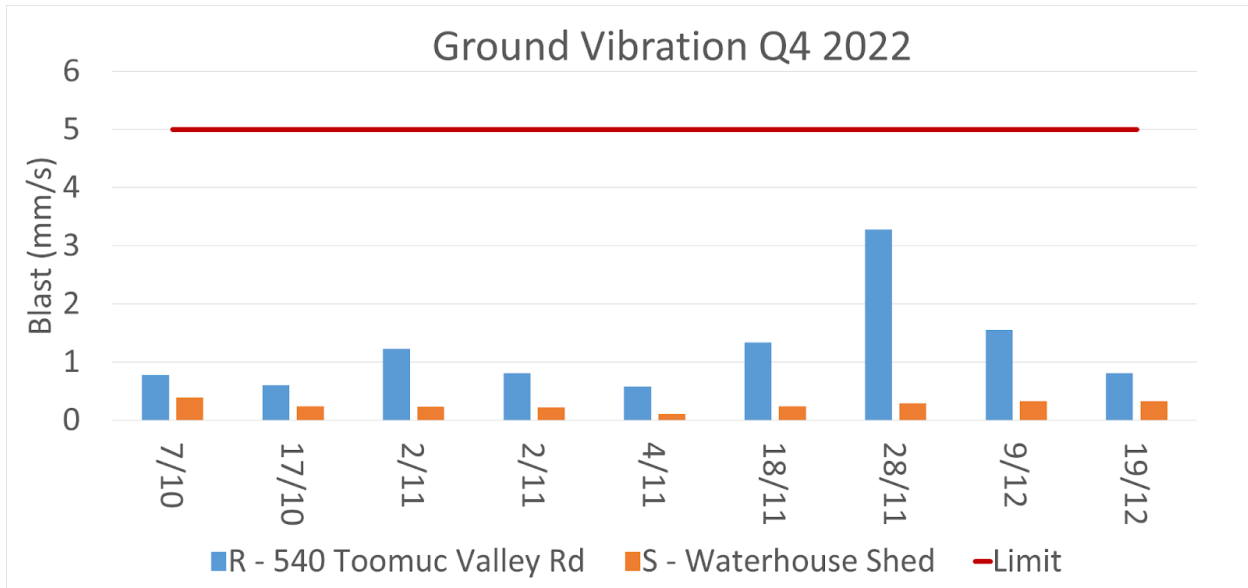
All blasting operations have been carried out in accordance with guidelines. No exceedances during the reporting period.

Figure 4 - Blasting; Ground Vibration Results Q4 2022 (Limit is 5mm/s for 95% of blasts in a 12 month period)

Ground Vibration Limits – Peak Particle Velocity (PPV) 5mm/sec at sensitive locations for 95% of blasts in a 12 month period

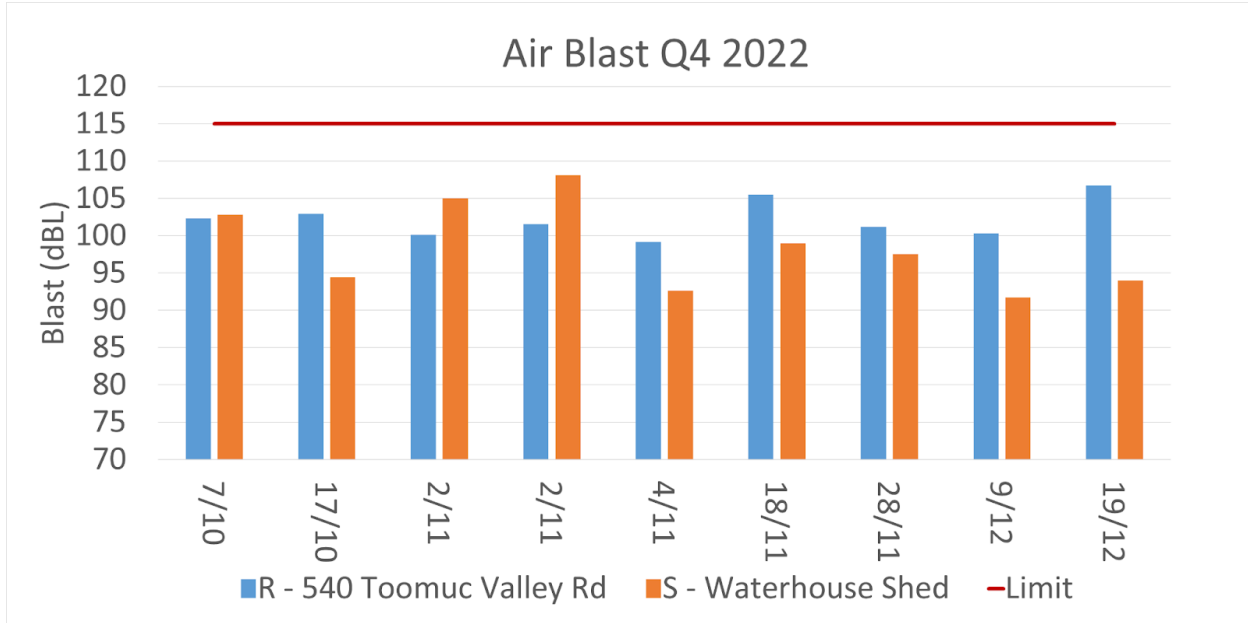
Figure 5 - Blasting; Air Blast Results Q4 2022 (Limit is 115 dBL for 95% of blasts in a 12 month period)

Air Blast Limits – Peak Air Blast of 115 dBL at sensitive locations for 95% of blasts in a 12 month period

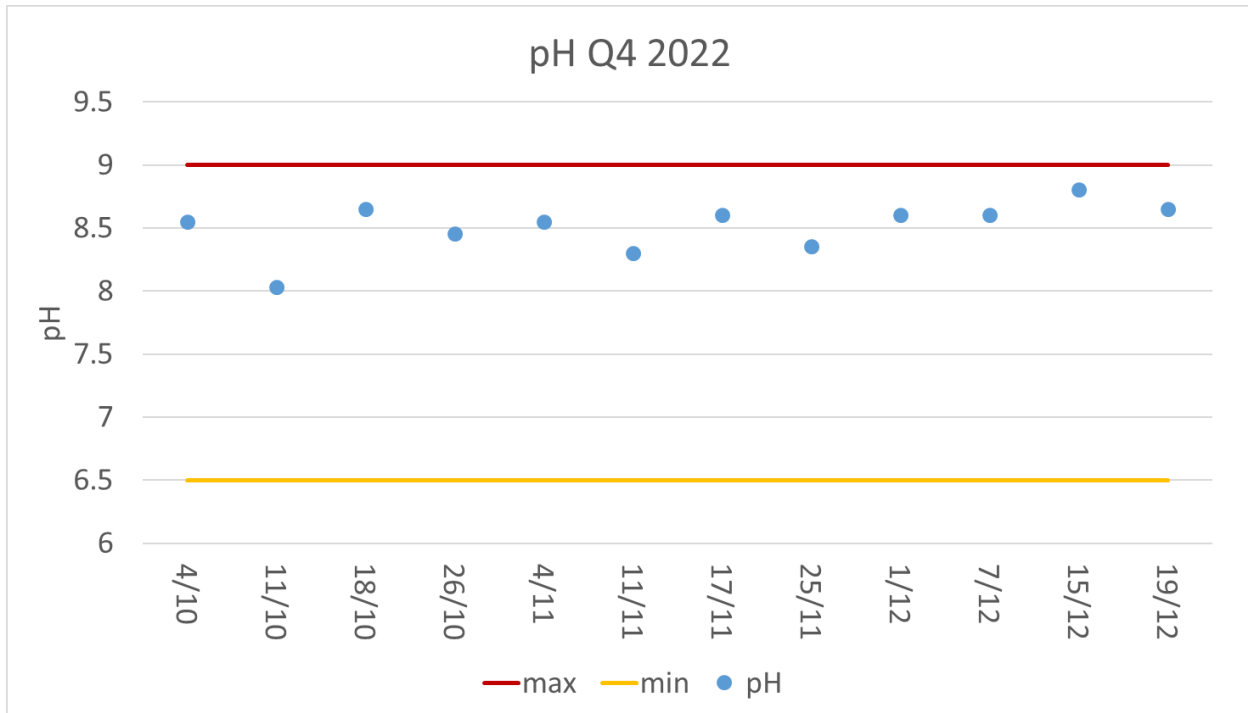
pH – A measure of the Acidity or Alkalinity of the water limit 6.5 to 9.0. No exceedances during the reporting period.

Figure 6 - Discharge Water pH results Q4 2022

pH – A measure of the Acidity or Alkalinity of the water. Limit 6.5-9.0

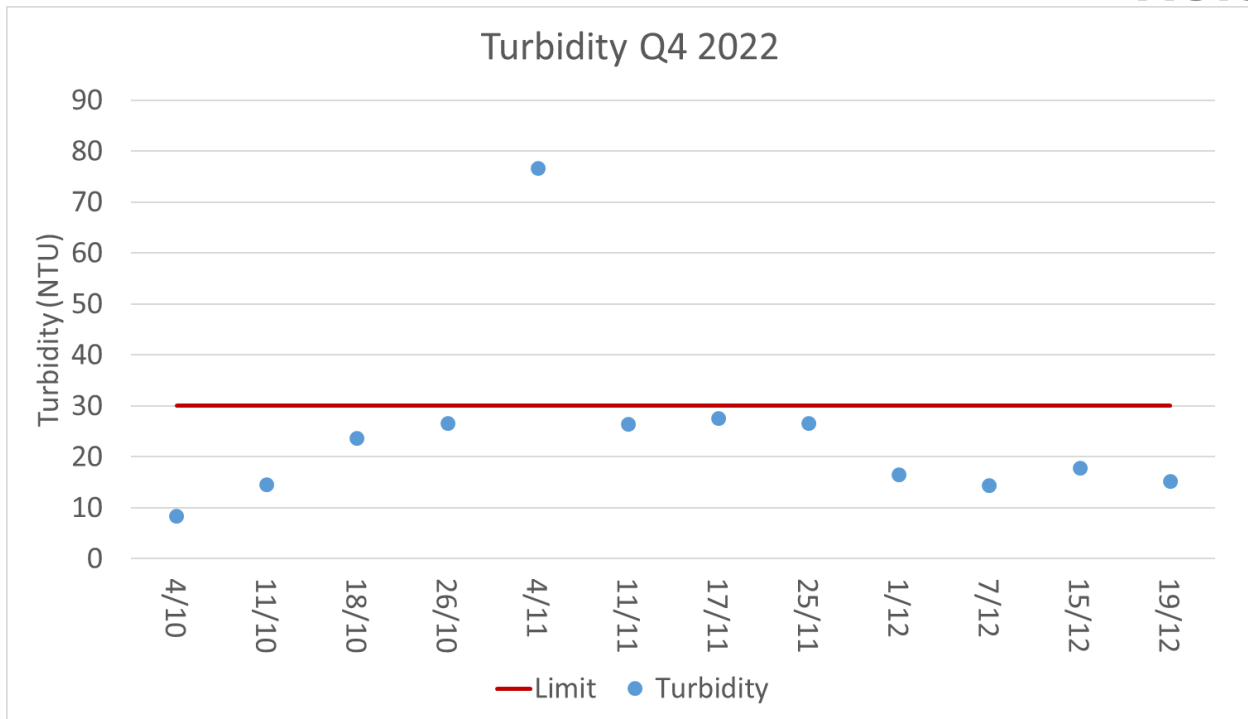
Turbidity – Clarity of water Maximum 30NTU.

One exceedance during the reporting period on the 4th November. After heavy rainfall, 83mm for the week, a turbidity result of 76.6NTU was obtained at the V-Notch. The compliance limit is 30NTU. pH and electrical conductivity were both within compliance limits. Reported to EPA and ICARE event # INC-0222089. Pit water was being pumped at the time which had 5.3 NTU.

Figure 7- Discharge Water Turbidity results Q4 2022

- 4th November - Testing conducted at the licensed discharge point returned a turbidity result of 76.6NTU, the compliance limit is 30NTU. All other results were below the compliance limit (PH8.55, Electrical Conductivity 526). Elevated turbidity was from heavy rain during the week (83mm). Pit water was being pumped at the time which had 5.3 NTU.

Turbidity – Clarity of water. Maximum 30NTU

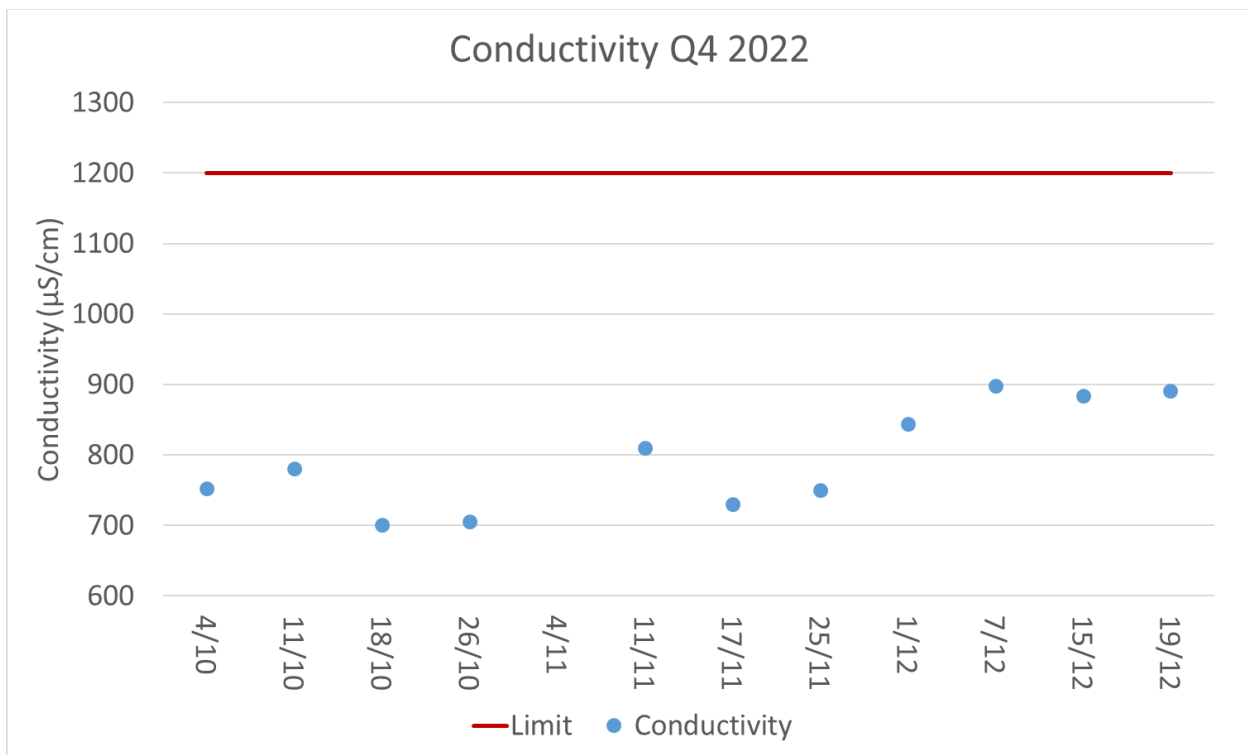
Conductivity – A measure of the water’s capability to pass electrical current. Limit 1200 μ S. No exceedances during the reporting period.

Figure 8 - Discharge Water Conductivity results Q4 2022

Conductivity – A measure of the water’s capability to pass electrical current. Limit 1200 μ S

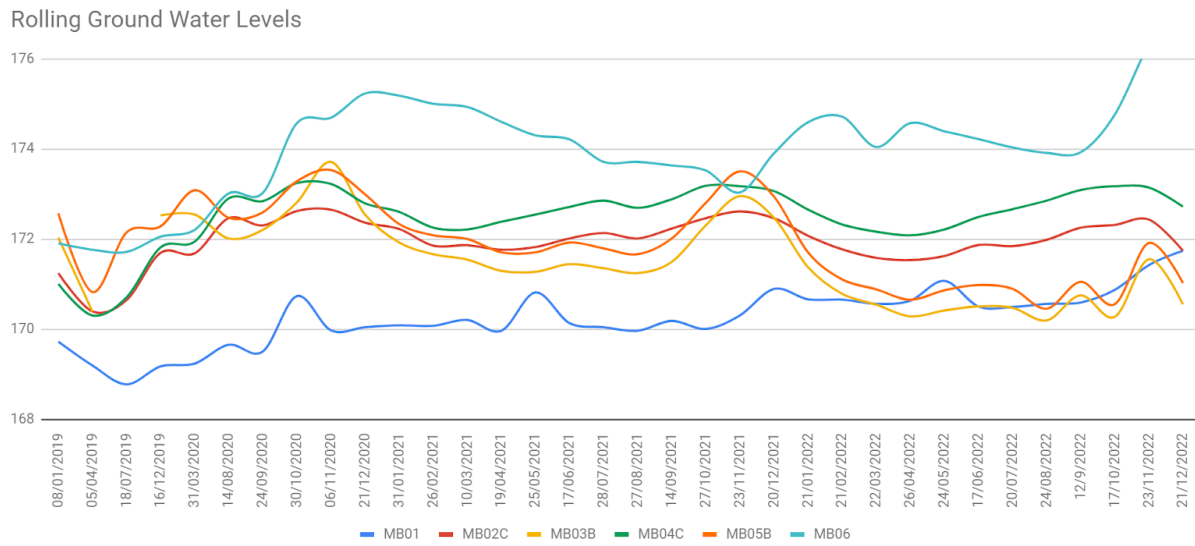
Figure 9 - Groundwater levels 2019 to present.

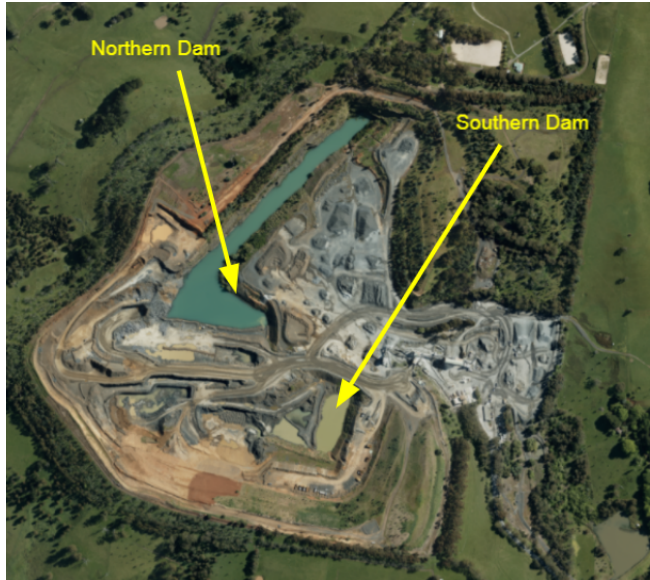
In 2020, Holcim committed to begin and report the in pit water dam levels quarterly, to aid in the annual beneficial use analysis. This was formed as part of the revised EMP submission. Location and naming conventions are shown in the map for reference. All measurements are in RL's (the same unit as ground water levels)

Figure 10 - In Pit Water Identification

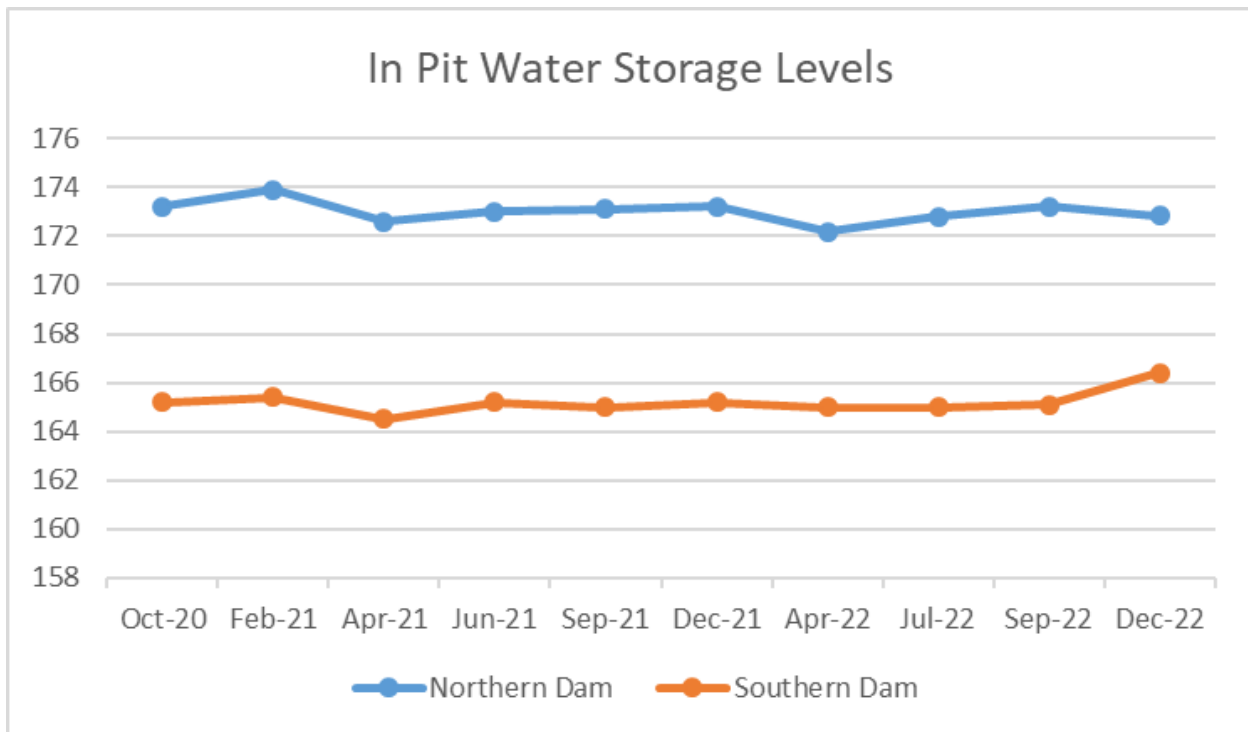
Figure 11 - In Pit Storage Levels October 2020 - Present

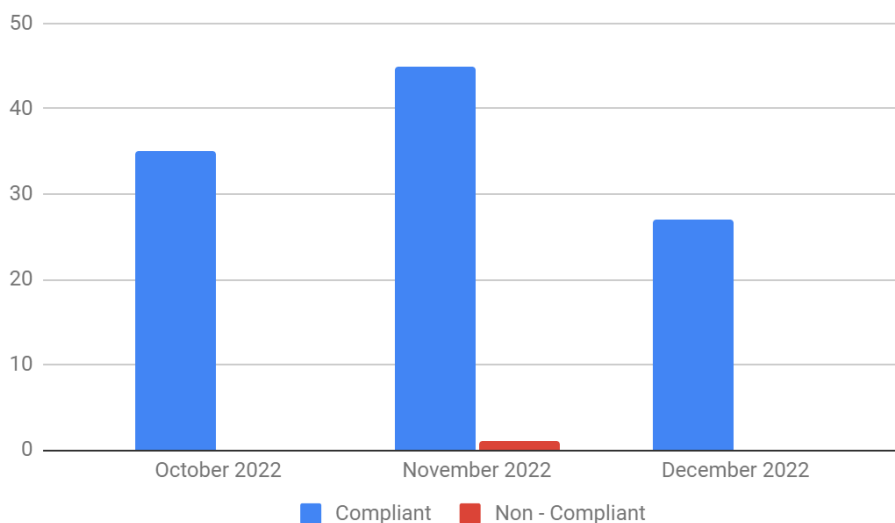
One truck was observed with truck tarped but trailer not tarped, 08/11/2022 - HAZID-0474050.

Figure 13 - Tarping visual checks of Q4 2022
