Mt Shamrock Quarry Rehabilitation Report

Site Location: Holcim Mt Shamrock Quarry Mt Shamrock Rd, Pakenham Upper, Vic,

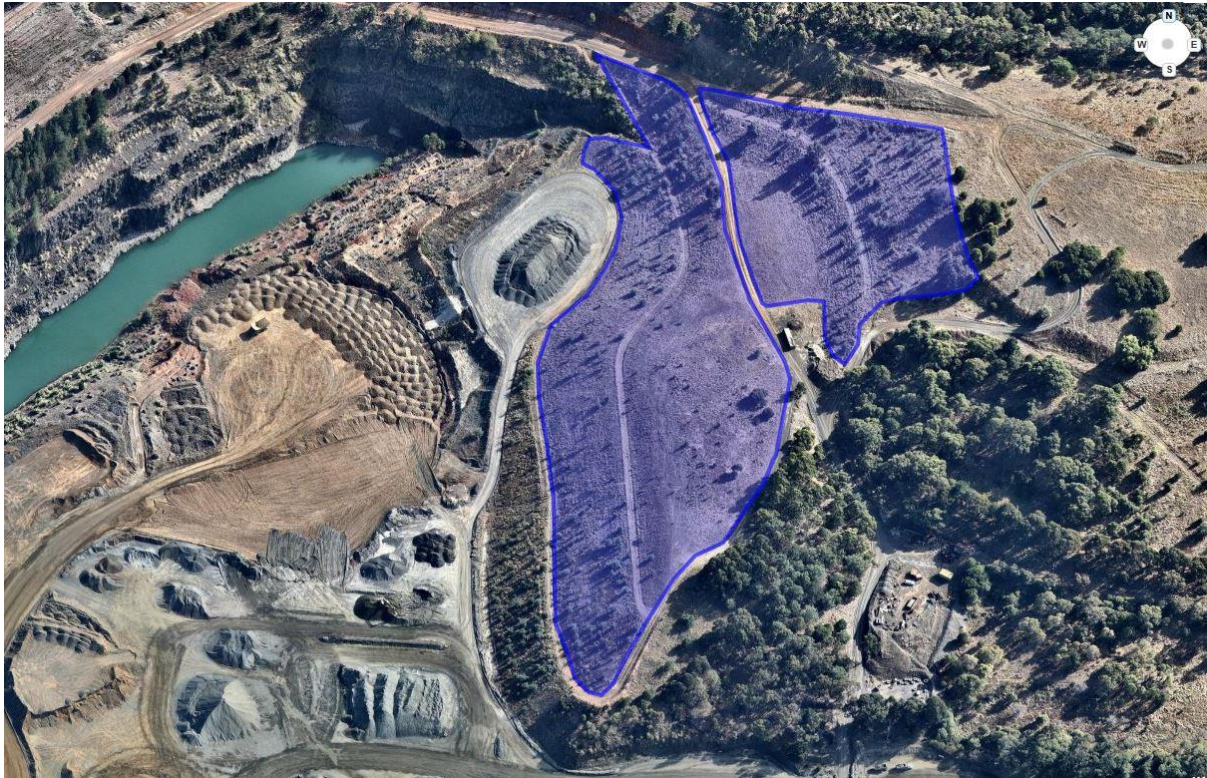
The area referred to as Extraction re-vegetation refers to the first rehabilitated area within the Mt Shamrock quarry area undertaken by Naturelinks and is 4Ha in total (Figure 1). Works undertaken included direct seeding using a sterile cover crop and native seed mix and the planting of 1812 tube-stock of mid and upper strata species and the planting of understorey species that were unviable to

Figure 1: 2015 Mt Shamrock ‘Extraction’ Re-vegetation area (4Ha).

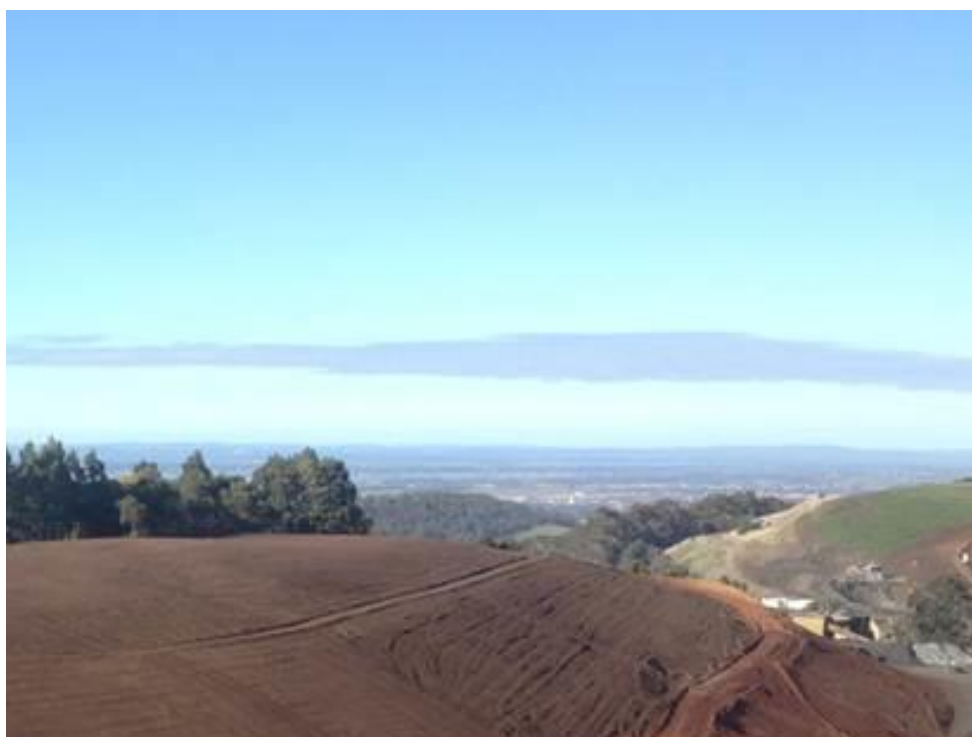
Firstly, site preparation was undertaken by Holcim in the form of spreading top-soil across the re-vegetation site (Figure 2). Naturelinks then undertook weed control works in the form of two non-selective spray runs throughout the site in order to minimise the presence and spread of invasive species in the area. Following these spray works, hydro-seeding was undertaken in two parts; with 2Ha carried out in May 2015 and the remaining 2Ha seeded in July 2015. Direct seeding was carried out by Hydrograss Pty Ltd. using a native and sterile Rye seed mix embedded within a liquid mulch applied directly to the bare earth. Table 3 refers to the seed mix and proportions for each species along with sowing rates, all native seed is sown at 40kg/Ha in conjunction with the cover crop of Sterile Rye Corn sown at a rate of 100kg/Ha. Combined 140kg/Ha of seed was sown on site.

Figure 2: Part of the extraction area to be rehabilitated after topsoil was spread over the site.

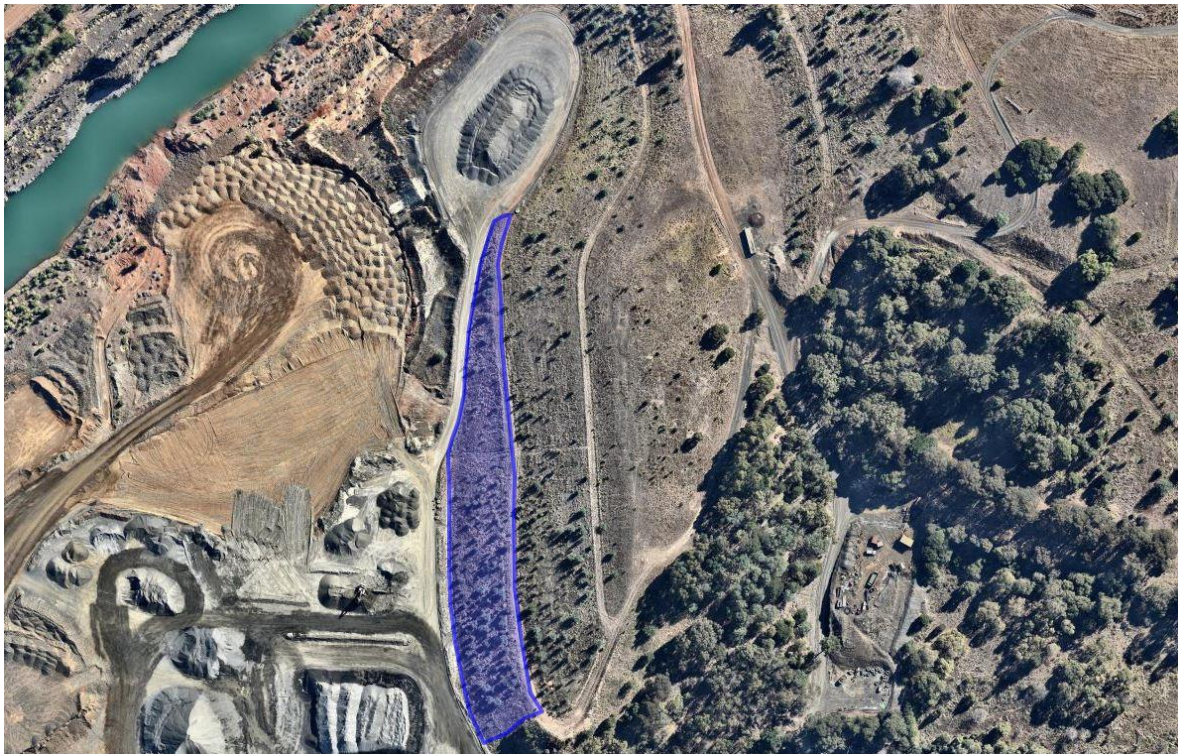
Re-vegetation works undertaken by Naturelinks in 2016 were located in an area directly adjacent to the 2015 works (Figure 2). Works carried out in 2016 were similar to those of 2015 with some slight variation in species numbers and seed proportions (Tables 4&5). Hydro-seeding was again undertaken in May of 2016 following preparatory spray works with mid/upper strata species planted, staked and guarded in July of 2016 along with additional understorey species (*L. longifolia* and *D. repens*).

Figure 3: 2016 1Ha Re-vegetation area at Mt Shamrock Quarry.

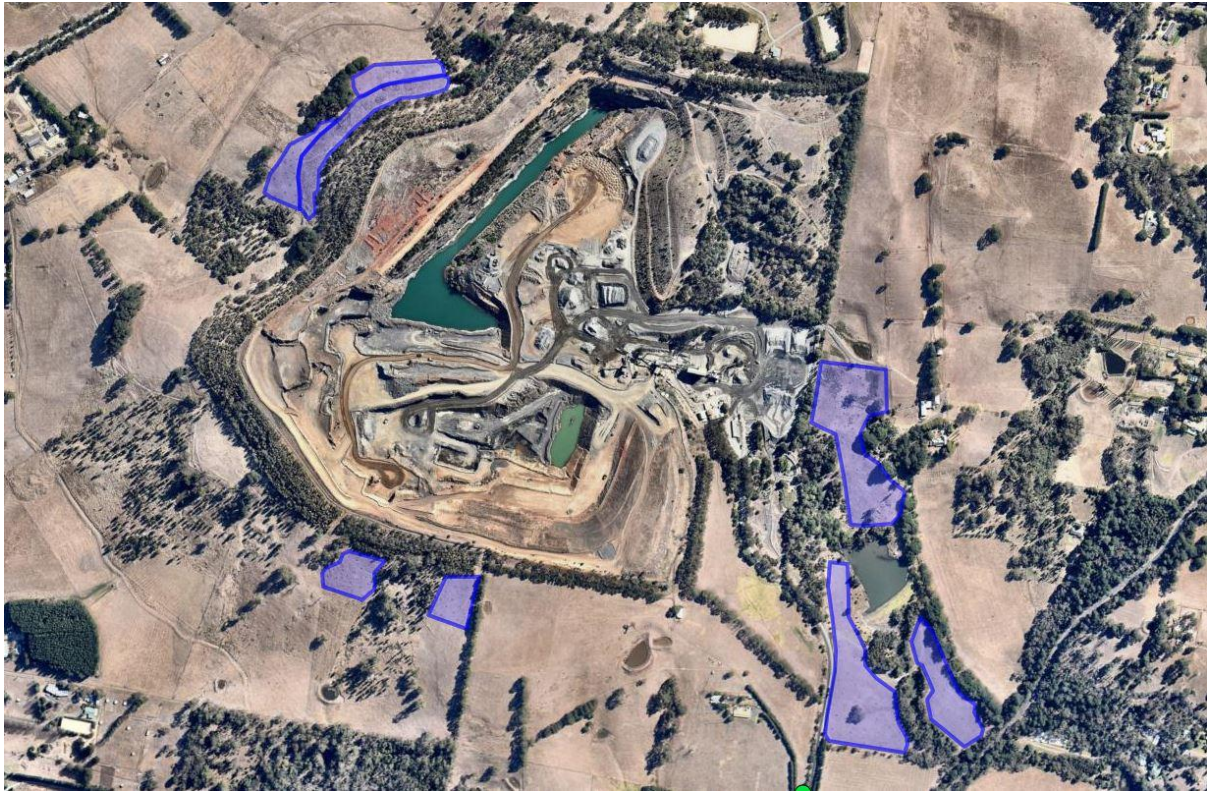
Phase C re-vegetation works undertaken by Naturelinks to Non-Quarry Operational Area: Landscape Plan Planting Phase C (L4a). These areas were planted with 1080 over-storey species only at an average stocking density of 18m squared per plant. Stock proof fencing was erected by Holcim for a total of 150 species planted in grazing areas and all remaining individuals were staked and guarded (see Table 6 for species numbers). Preparatory works were undertaken to spray out and remove biomass in planting areas prior to planting.

Figure 4: Phase C 2016 Scattered planting Areas.

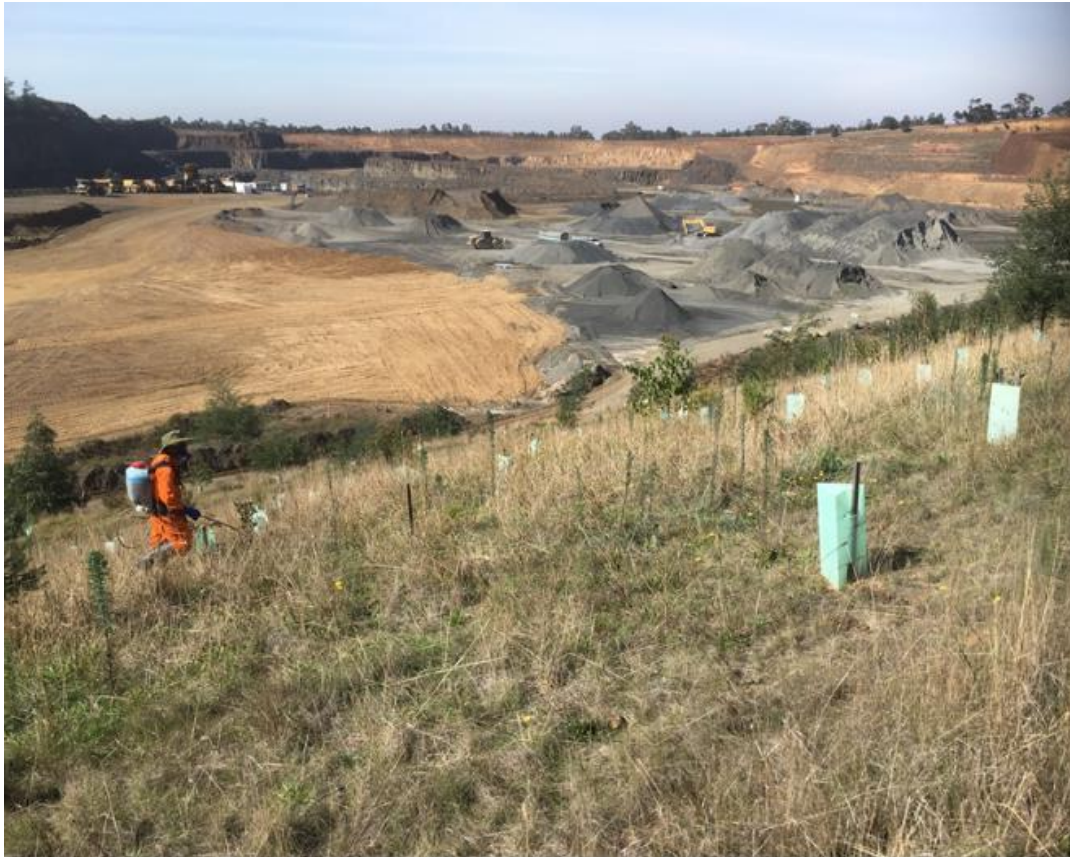
Weed management practices undertaken by Naturelinks predominantly centre on selective and non-selective herbicide application delivered by either high pressure quick spray units or knapsack spray works for more sensitive areas. Selective herbicide runs utilising broadleaf only herbicides is often undertaken as large areas can be sprayed at a time using Quicksprays without damage occurring to the native grass dominated understorey. This cannot occur when targeting grassy weeds using a non-selective herbicide like Weedmaster Duo as damage would occur to the native grasses. Where weed control targeting perennial exotic grasses occurs, knapsack only spraying is undertaken to avoid any off target damage occurring (Figure 5). Whilst this is a slower process it is necessary to maintain the condition of native vegetation present in the understorey whilst controlling invasive weeds.

Figure 5: Non-selective knapsack spray works undertaken at Extraction planting area

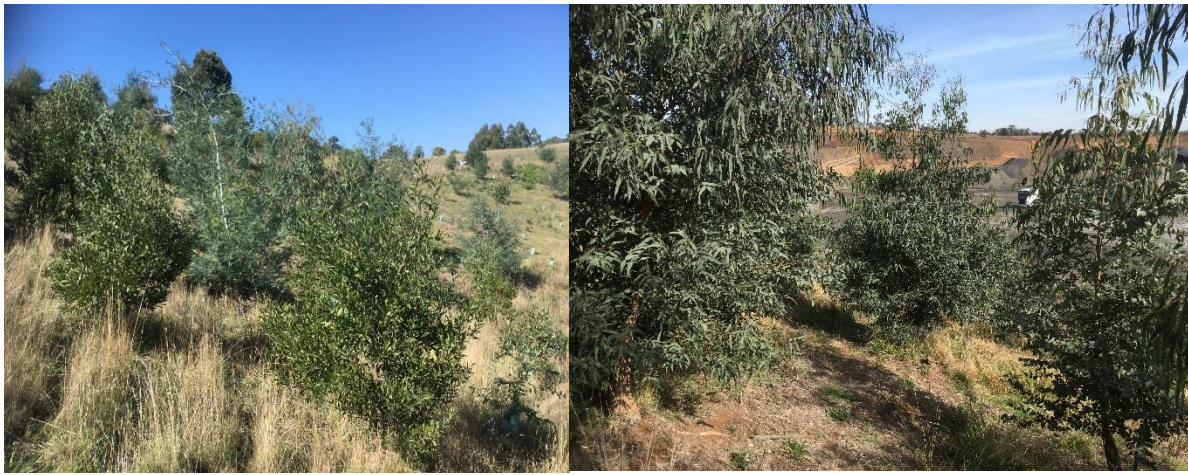
Rates of tree and shrub growth across the site have been varied and patchy. As is the case with the increased presence of weed species as discussed above, areas with increased soil moisture and soil depth appear to promote superior growth rate in trees and shrubs when compared to areas with less soil depth (as evidenced by figures 6&7). Growth rates and survival rates in Phase C non-extraction area plantings have surpassed those planted in the extraction area. This likely due to a more intact layer of top-soil existing due to a lack of disturbance from mining operations.

Figures 6&7: Sloped areas with increased soil depth and soil moisture (water flow) showing high growth rates of trees.

It is apparent that an increase in soil depth and soil moisture increases growth rates for most trees and shrubs when compared to areas with little topsoil depth and flat areas. Each different area brings with it different challenges in regards to maintenance, with areas of low soil depth seeing a decrease in weed numbers and species present along with a reduced rate in tree and shrub growth rates and an increase mortality. These areas require less frequent efforts regarding weed control but will likely require weed control efforts for a longer period of time due to a delay in plant establishment and canopy cover when compared to other areas of the extraction rehabilitation areas. In contrast to this, areas with higher rates of growth see a more diverse number of weed species present at higher numbers than some surrounding areas. These areas require more intensive management during the development of a tree canopy. However, given the context of the site, which is surrounded by agricultural land and exposed to high winds bringing with it weed seed and high rainfall, ongoing weed management of this site is essential if indigenous vegetation is to dominate the site. This is of particular importance for understorey species as these are most vulnerable to competition from invasive species.

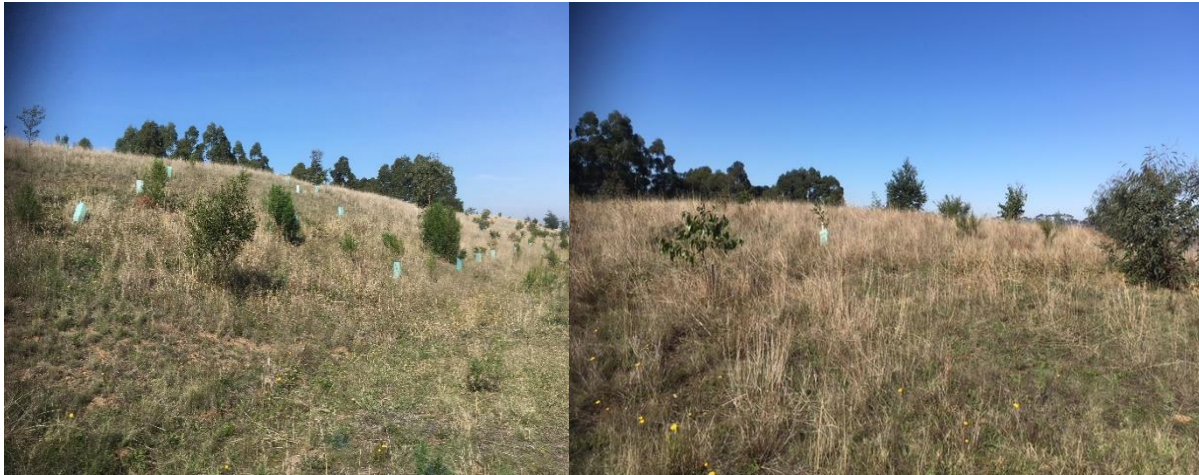
Figures 8&9: Areas with less soil depth exhibiting reduced rates of tree growth compared to above.
